**Assessment and Analysis of Adaptation Alternatives  
For Coskata-Coatue Wildlife Refuge Properties**

**April 2022**

Woods Hole Group  
A CLS Company  
107 Waterhouse Road  
Bourne, MA 02532 USA  
(508) 540-8080

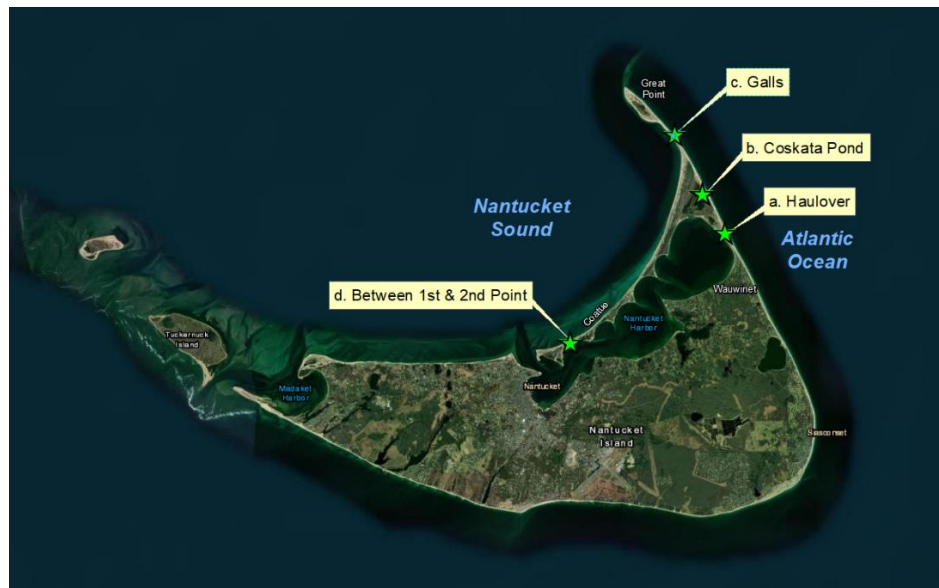
**Figure 1. Locus map of the Trustees and Nantucket Conservation Foundation properties.**

- 1) Identifying adaptive alternatives to maintain barrier beach and dune integrity focused on the four selected areas (Figure 1) of high vulnerability to overwash and erosion including:
  - a. The Haulover
  - b. Coskata Pond
  - c. The Galls
  - d. Coatue Between 1st and 2nd Point

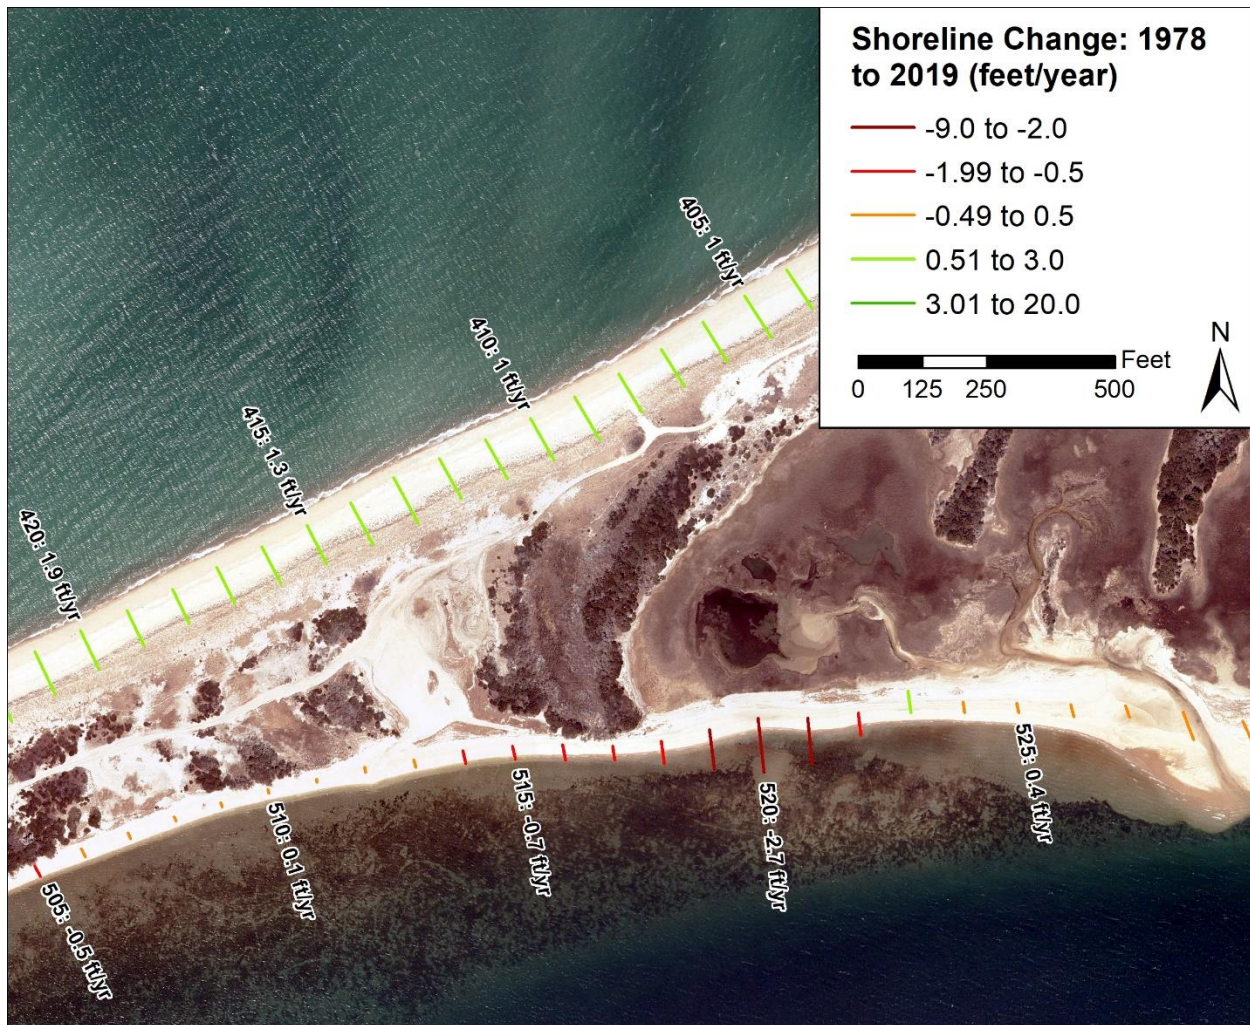
**Figure 15. Short-term shoreline change rates between 1st and 2nd Point (1978-2019).**  
Background imagery is 2019 MassGIS imagery. Negative values indicate erosion, while positive values indicate accretion.

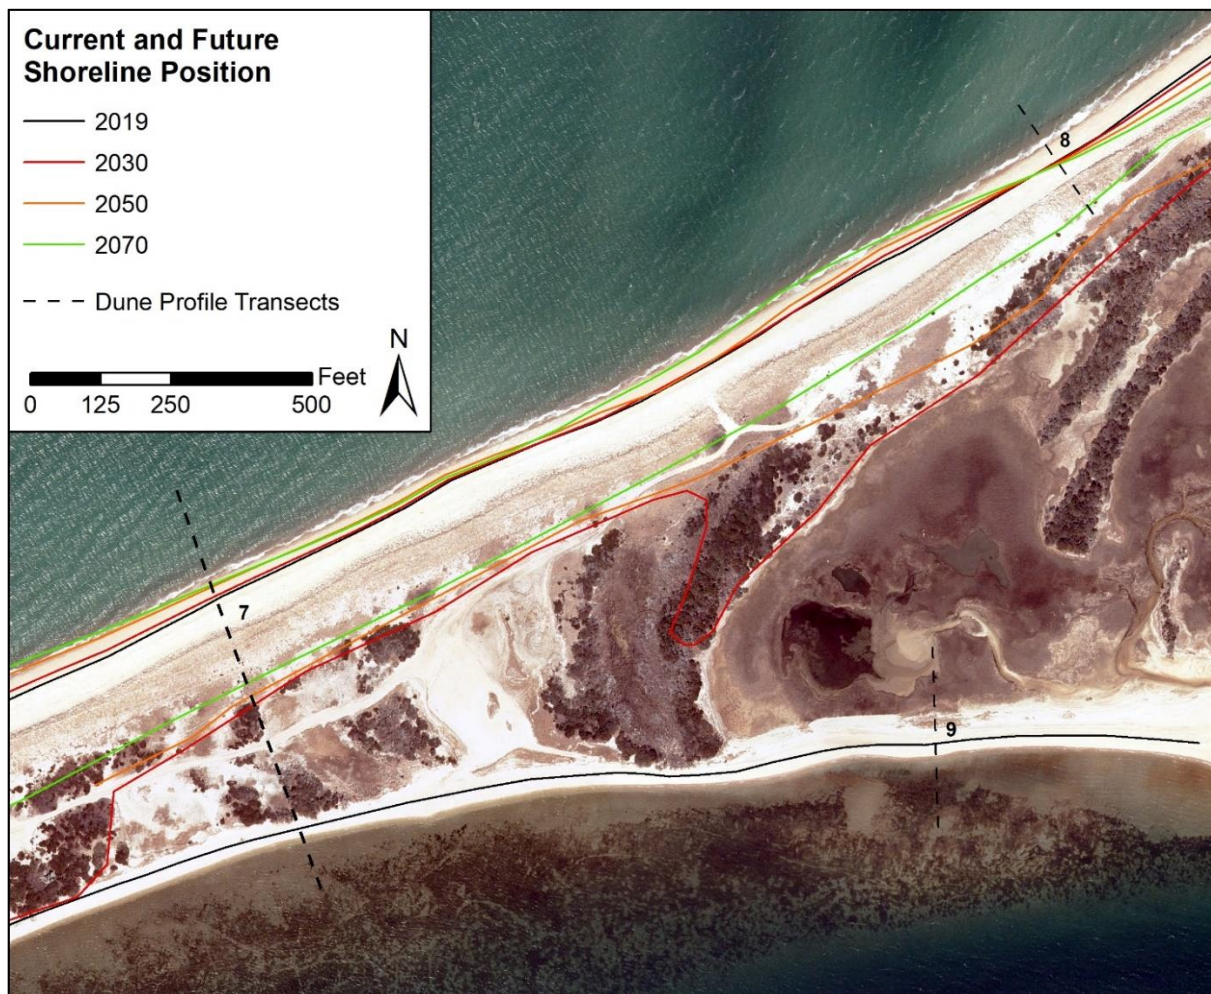
**Figure 26. Current and future shoreline positions between 1st and 2nd Point. Dune profile transect data for Transect 7 is displayed in Figure 25.**

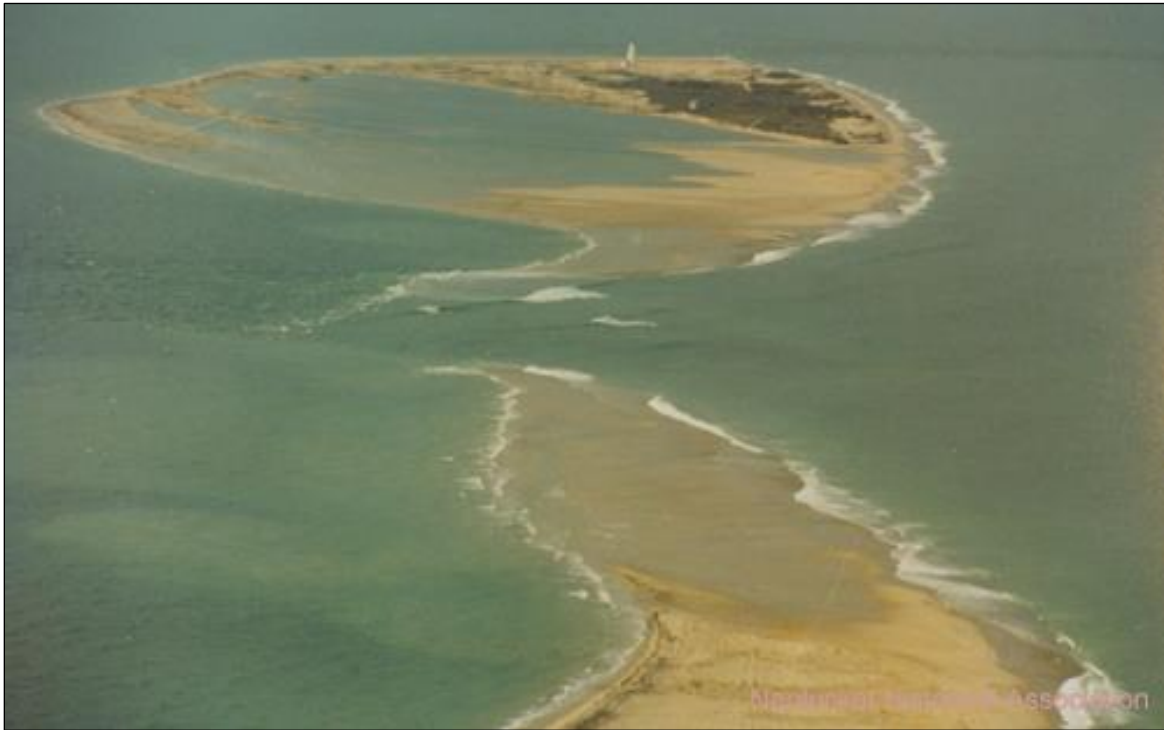
**Figure 30. Breach remaining at The Galls in January 1992 (Image courtesy of Nantucket Historical Association).**

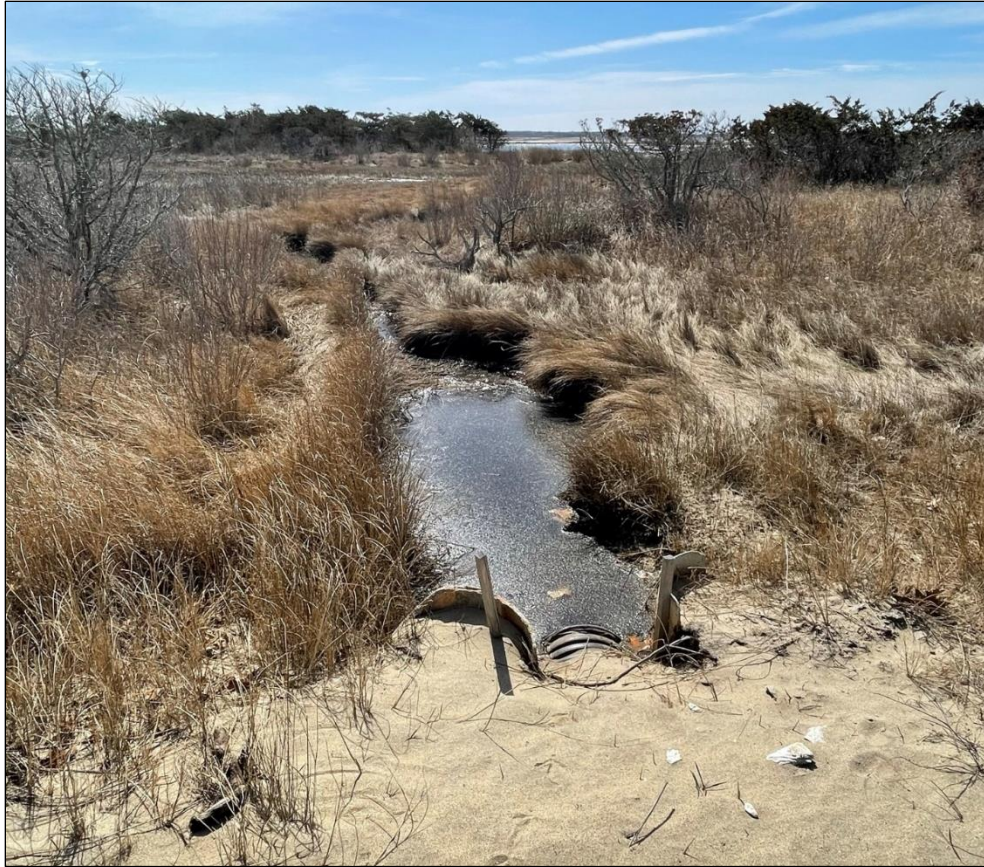
**Figure 45. Existing corrugated plastic pipe under road.**

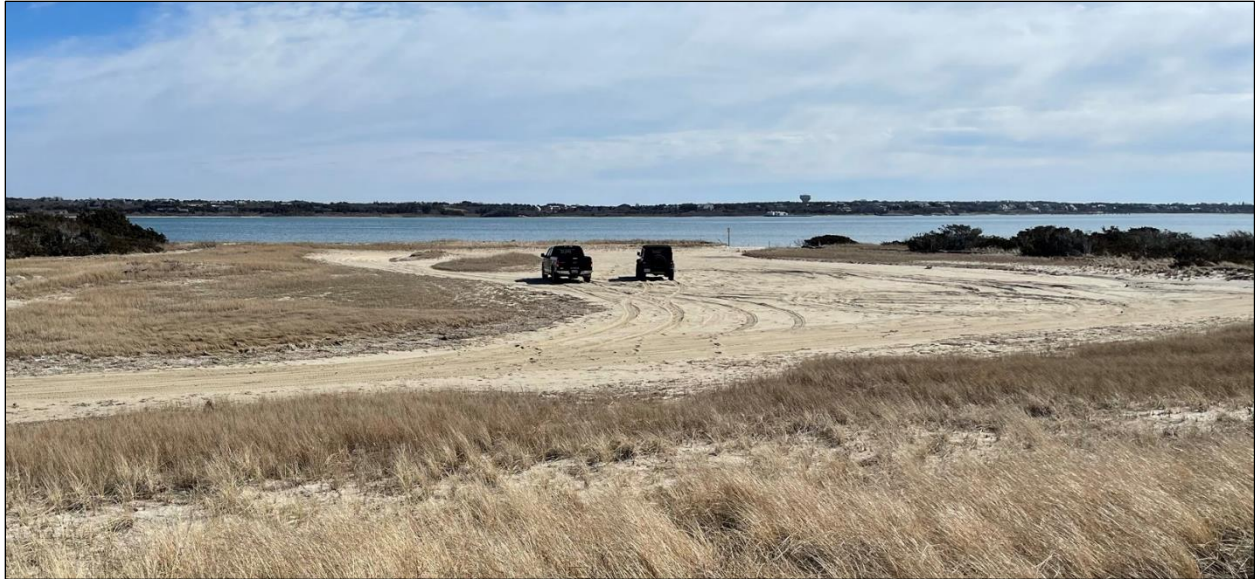
**Figure 59. Low-lying dirt parking area between 1st and 2nd Point.**

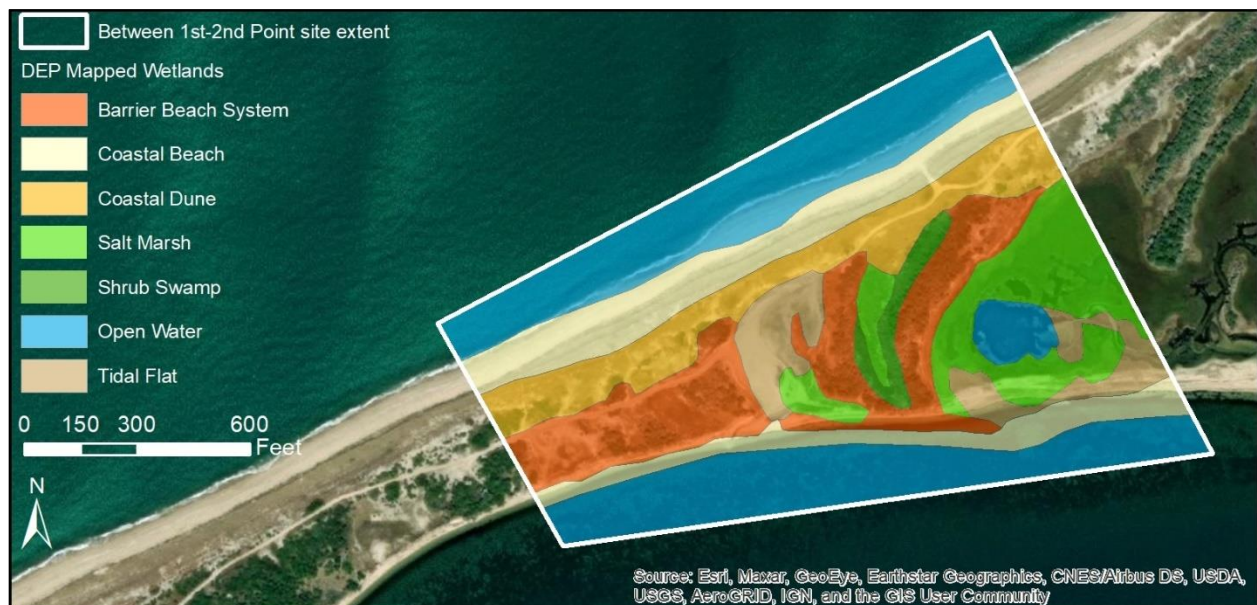
**Figure 60. Existing wetland resource areas, as mapped by MassDEP, between 1st and 2nd Point.**

The wetland resource area mapping produced by MassDEP shows the range of wetland habitats present between 1st and 2nd Point (Figure 60). Coastal beach and coastal dune are found along the northern (Nantucket Sound) side of the barrier beach. Forest- and shrub-dominated areas of the barrier beach are classified as “barrier beach system”. There is also significant salt marsh area in a lagoon connected to Nantucket Harbor through various circuitous inlets. Note that the dirt parking area mentioned above is classified by DEP as “tidal flat”.

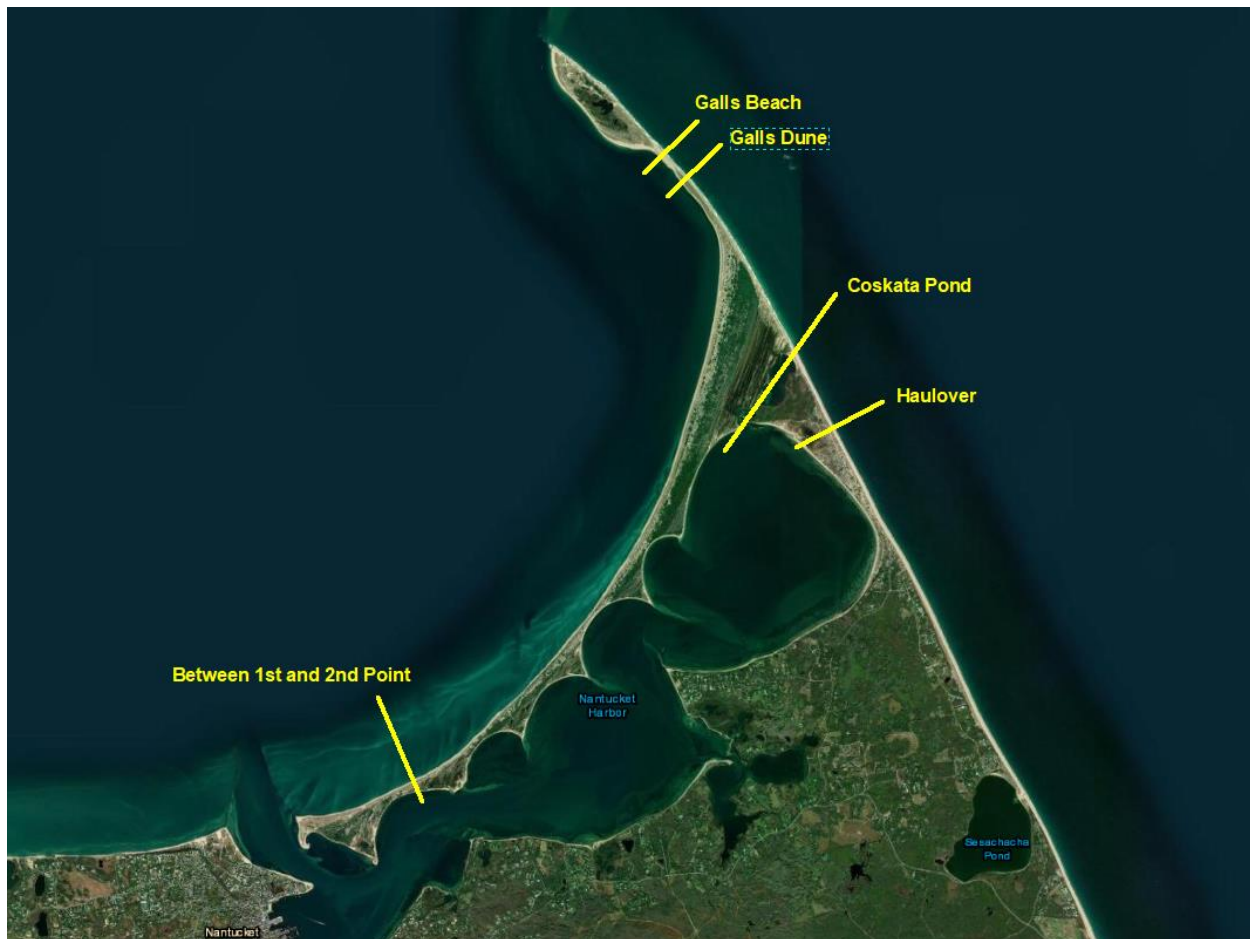
**Figure 69. Transect locations.**

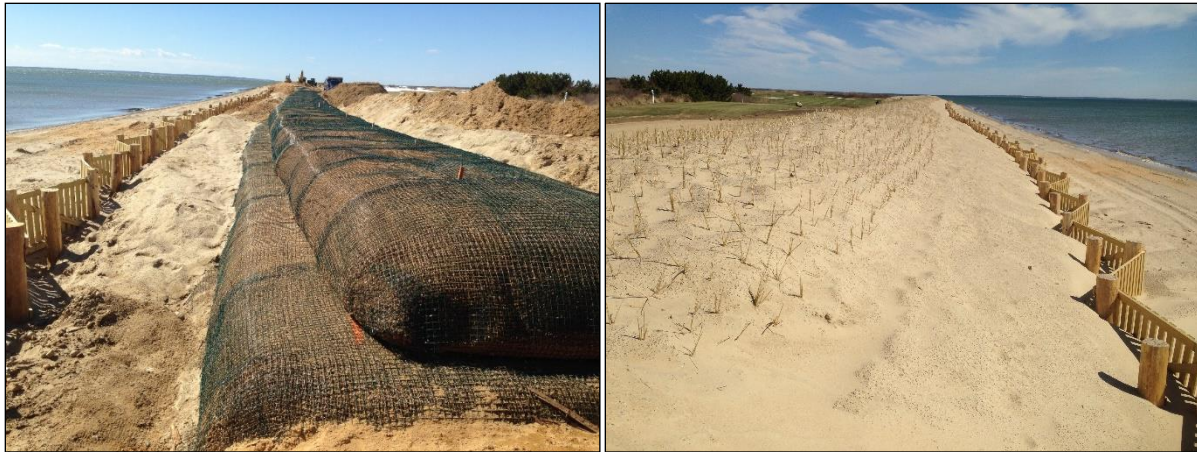
**Figure 82. Example of a coir project on Cape Cod, located in NHESP habitat.**

Dune stabilization projects using a bioengineered solution provide enhanced toe protection to the coastal dune and inland assets while restoring and enhancing the recreational value of the coastal beach, which is highly desirable. This alternative involves the installation of fiber rolls or sand filled coir envelopes at the toe of the dune to prevent undercutting and installing compatible nourishment sand on top to protect the fragile bioengineered material that will quickly degrade with prolonged exposure to UV light. Figure 82 is an example of a bioengineered project on Cape Cod. The addition of coir envelopes for toe protection can bolster the beach and dune nourishment alternatives discussed above and are considered a “soft” solution, often permitted under the State Wetlands Protection Regulations, 310 CMR 10.00. This solution had been previously permitted and installed at many other locations on Cape Cod and Nantucket and is considered a viable alternative for coastal stabilization on properties where hard coastal engineering structures are undesirable or prohibited by the State or Town. Dune stabilization can be paired with dune restoration to increase protection of the dune and allow greater time for the establishment of dune vegetation.

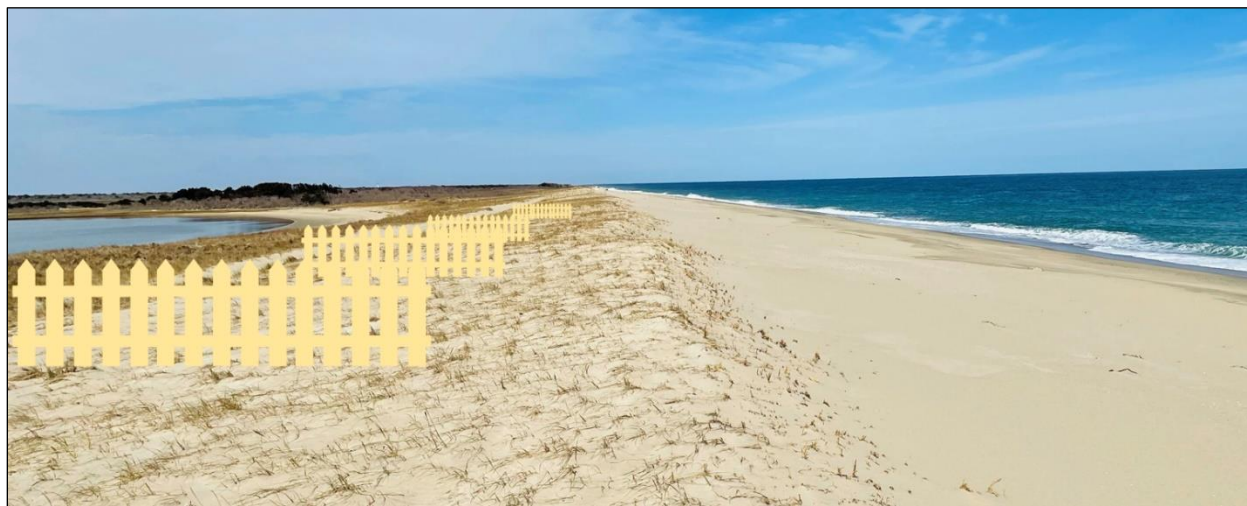
**Figure 97. Conceptual sand fencing placement along roadway at Coskata Pond.**

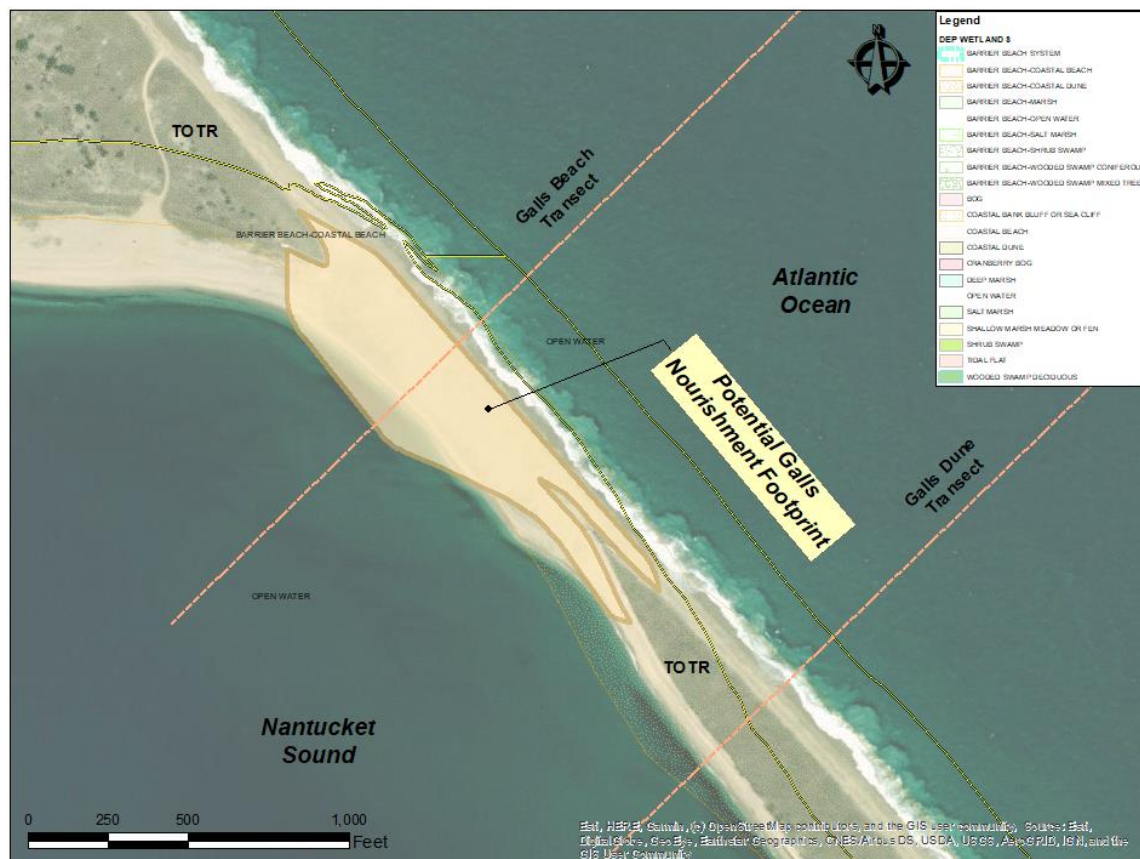
**Figure 104. Potential beach nourishment footprint at The Galls.**

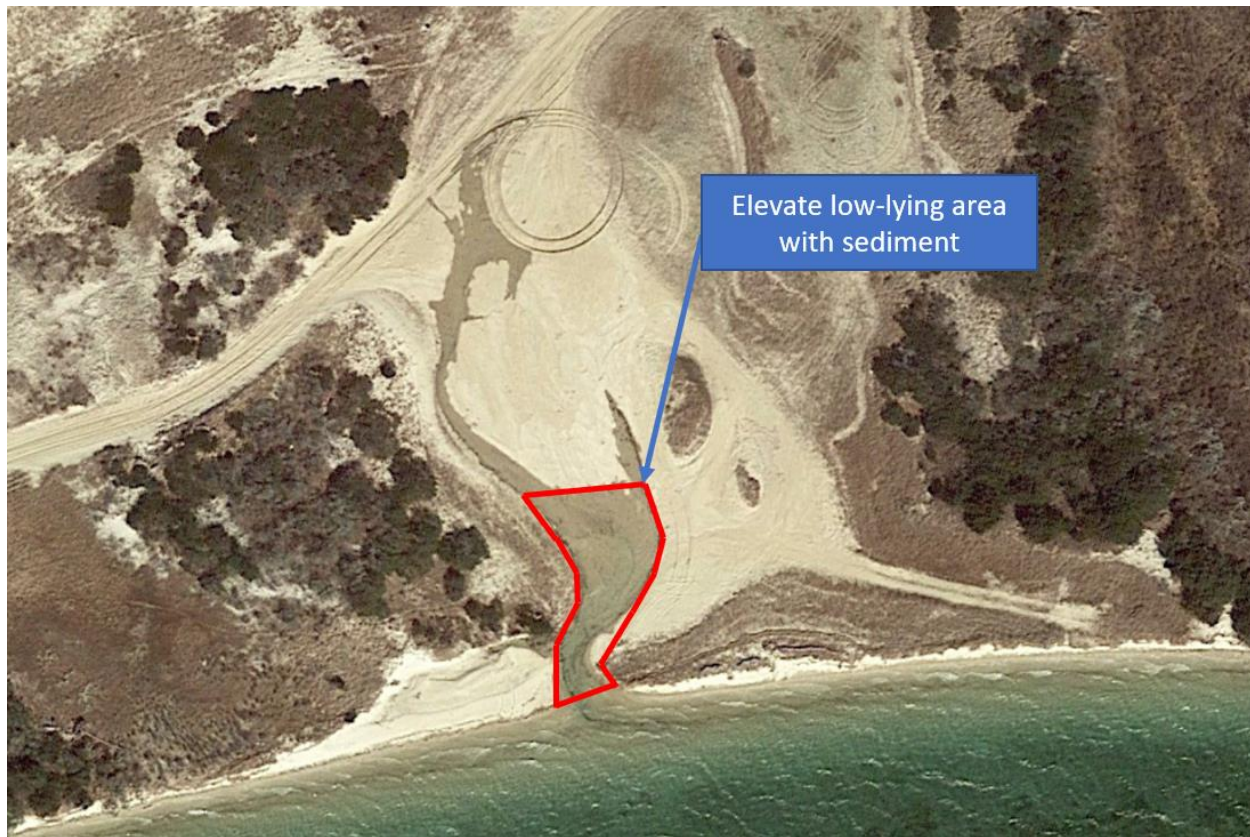
**Figure 107. Conceptual footprint for elevation with import at 1<sup>st</sup> and 2<sup>nd</sup> Point – February 2018 Aerial**
