# Alternative Access and Utility Relocation for Continuity of Services for Baxter Road Residents

Select Board Meeting – Project Update

January 11, 2023

Subject: Baxter Road Stabilization Project  
Sconset Beach  
Nantucket, MA

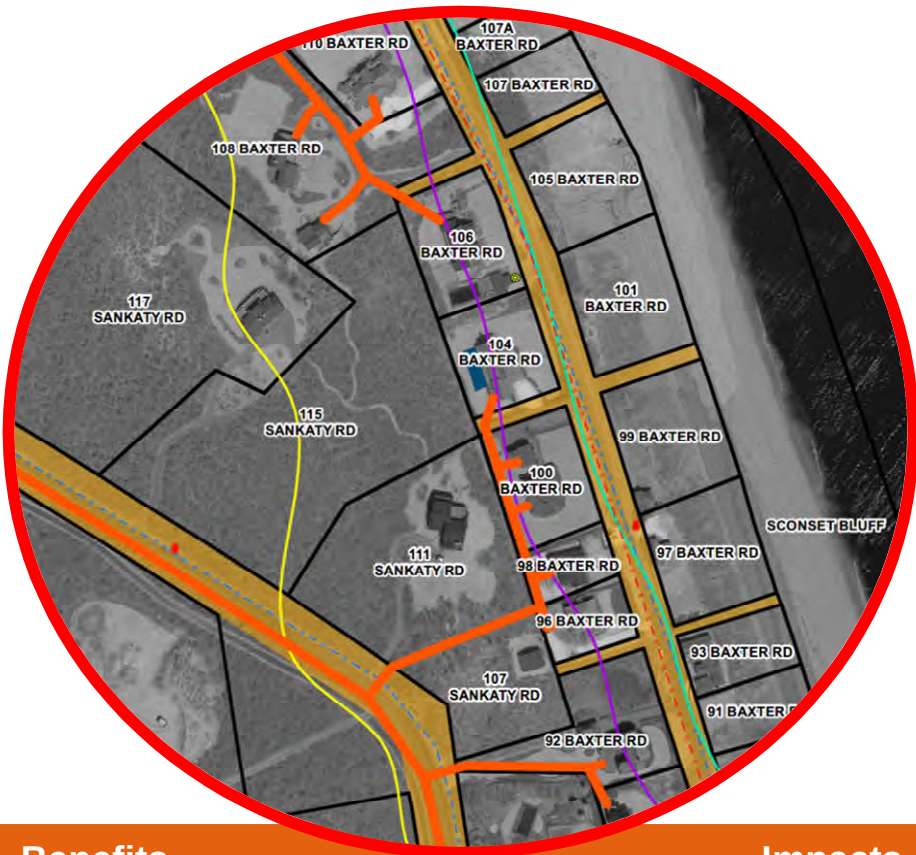
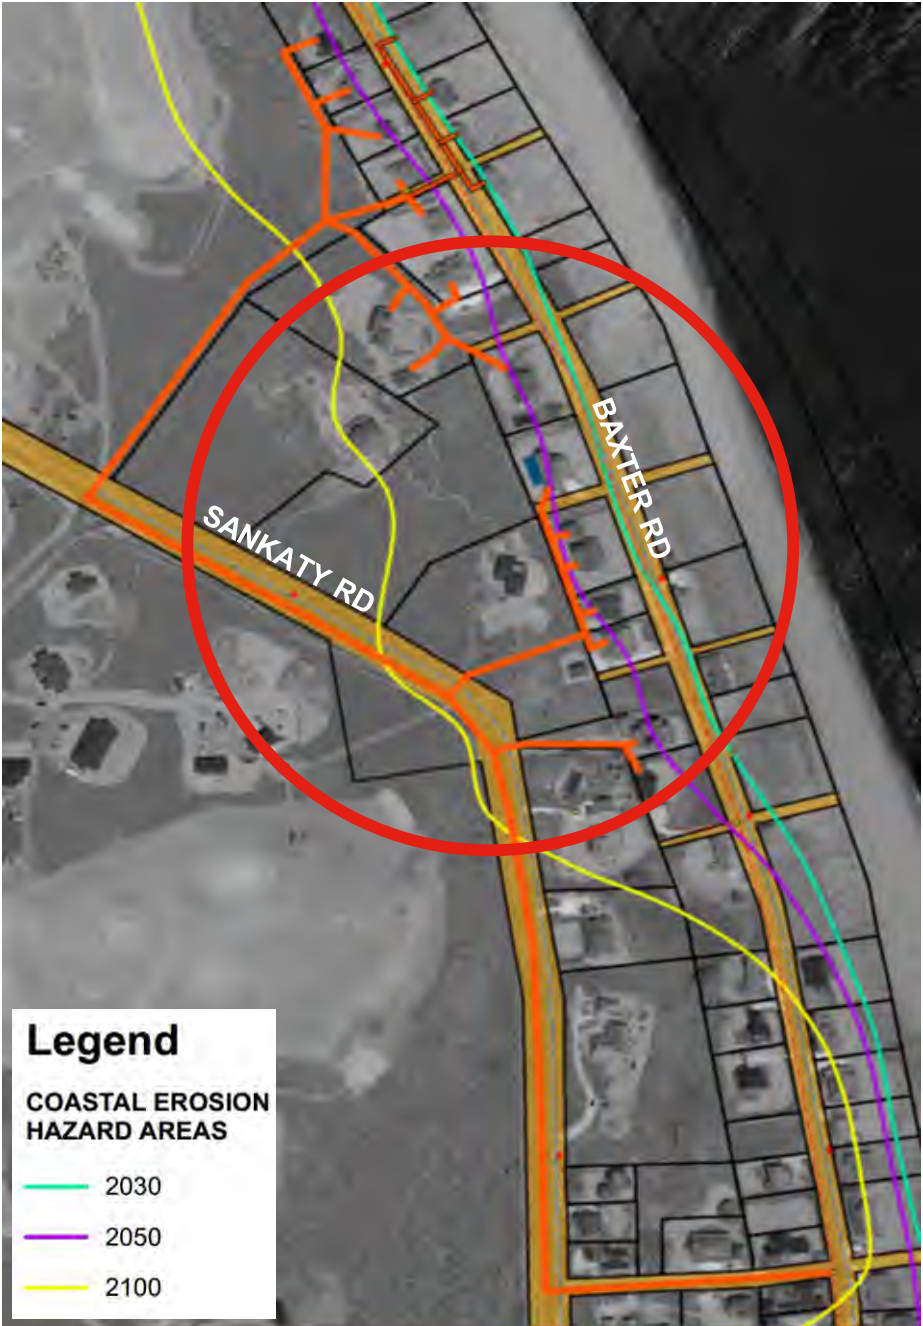
Option A

- Avoids existing swimming pools at 104 & 106 Baxter Road
- Minimizes disturbance to native plantings as 96, 98, 100, 104 Baxter have manicured lawns and landscaping
- Shortest overall length of the three options
- Minimizes disruption to family parcel groupings of 111, 115, 117 Sankaty and 108 Baxter
- Planned access for 90-92 Baxter to be a shared driveway with a maximum width of 15-feet

- Tight corridor between 100 Baxter & 111 Sankaty will impact privacy
- Tight corridor along 92 Baxter for 90 Baxter access will impact privacy
- Potential relocation of shed at 98 Baxter
- Planned access of two 10-foot travel lanes
- Disturbs native plantings between 107 & 111 Sankaty.
- Zoning variances may be required for setbacks

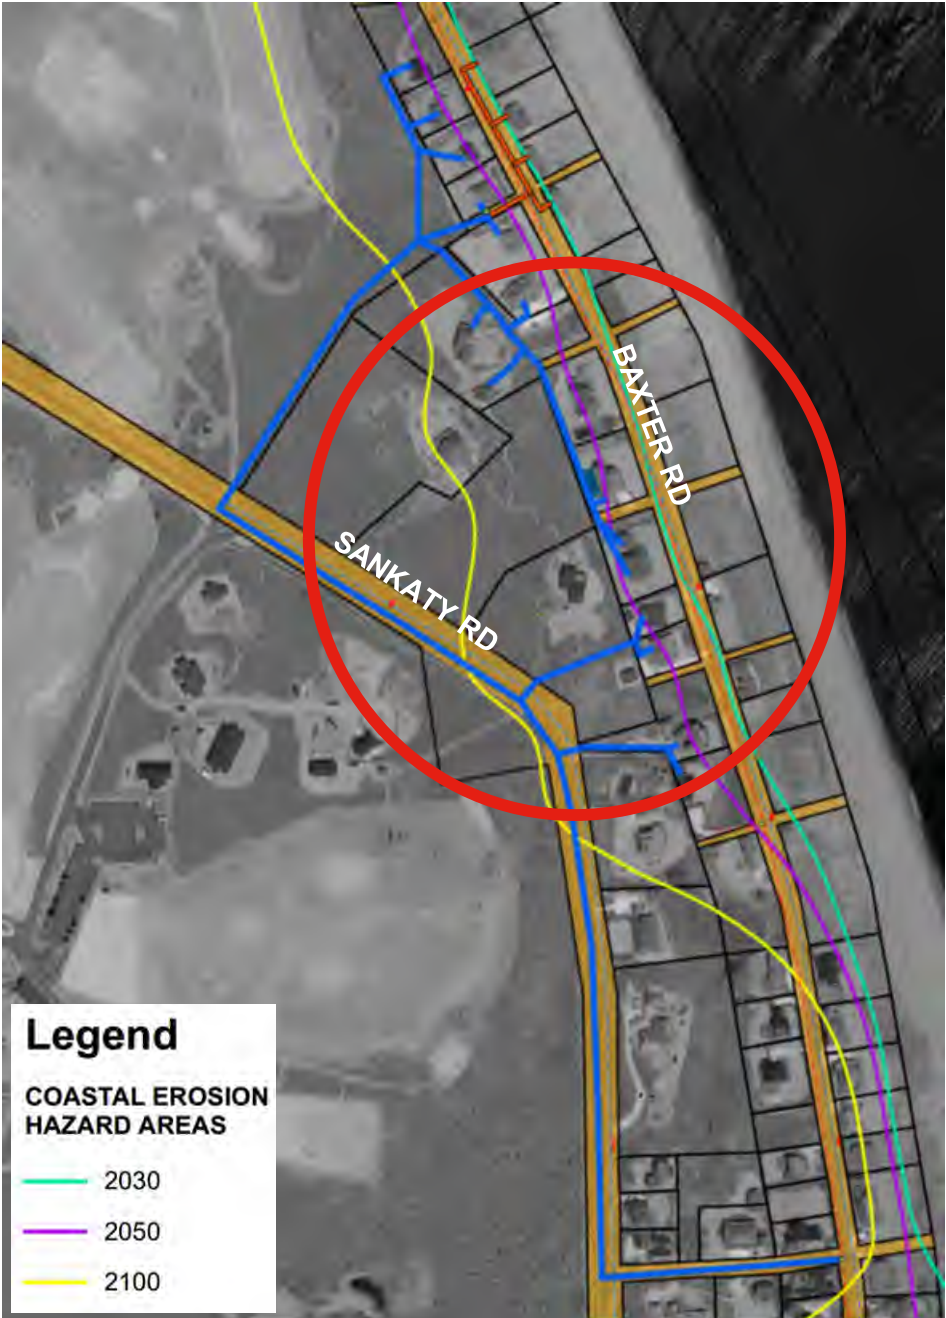
Option B

- Minimizes disturbance to native plantings as 96, 98, 100, 104 Baxter have manicured lawns and landscaping
- Avoids shed at 98 Baxter
- Planned access for 90-92 and 96-98 Baxter to be shared driveways with a maximum width of 15-feet
- Minimizes disruption to family parcel groupings of 111, 115, 117 Sankaty
- Second shortest overall length of the three options by 150-feet

- Swimming pools at 104 & 106 Baxter will be impacted
- Planned access of two 10-foot travel lanes for 100, 104, 106 & 108 Baxter
- Zoning variances may be required for setbacks

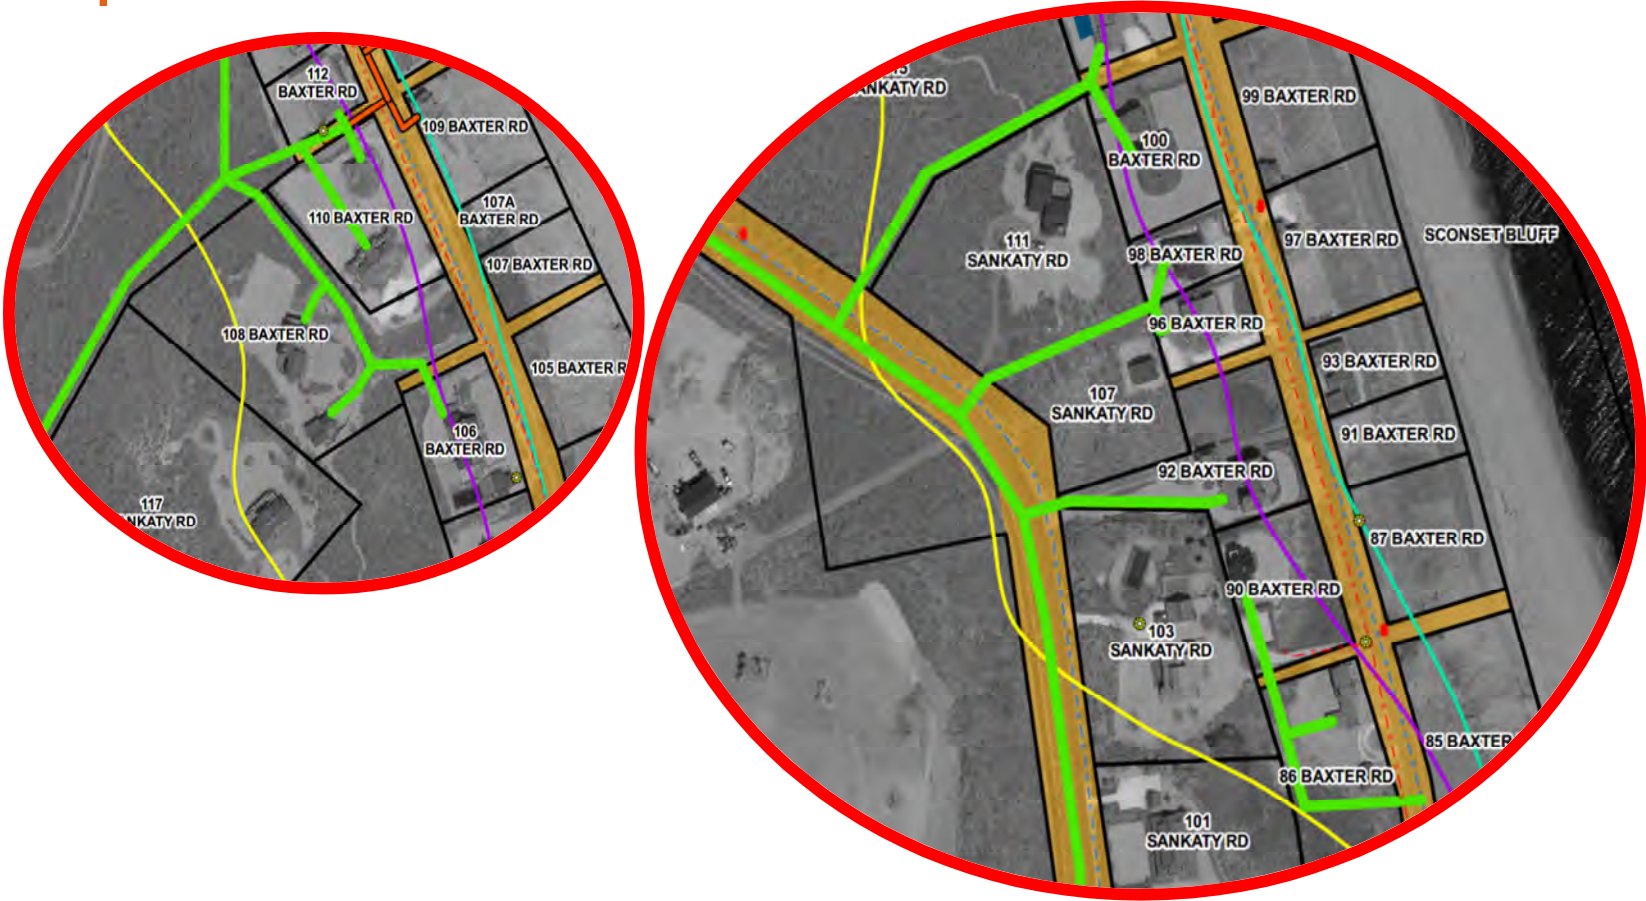
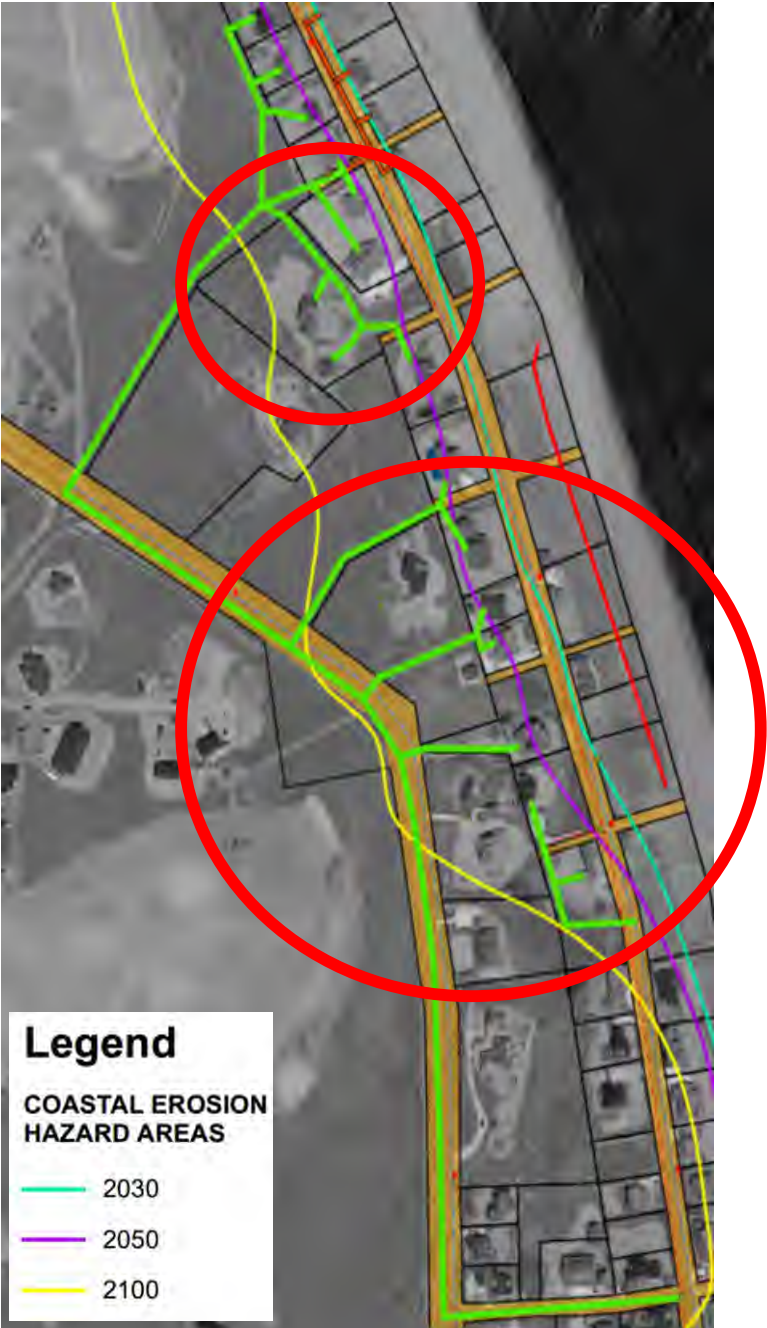
# Option C

| Benefits | Impacts |
|---|---|
| <ul style="list-style-type: none"><li>• Avoids existing swimming pools at 104 &amp; 106 Baxter</li><li>• Avoids shed at 98 Baxter</li><li>• Planned access for 86-90, 96-98 and 100-104 Baxter to be shared driveways with a maximum width of 15-feet</li></ul> | <ul style="list-style-type: none"><li>• Creates more disturbance to native plantings as compared to other Options</li><li>• Maximum disruption to family parcel groupings of 111, 115, 117 Sankaty</li><li>• Longest overall length of the three options thereby highest estimated cost.</li></ul> |
