Baxter Road Long Term Planning  
DRAFT Summary of Findings

**DATE**  
September 9, 2021

Vincent Murphy on behalf of Select Board and Town  
Administration of Nantucket

**PROJECT NUMBER**  
30078051

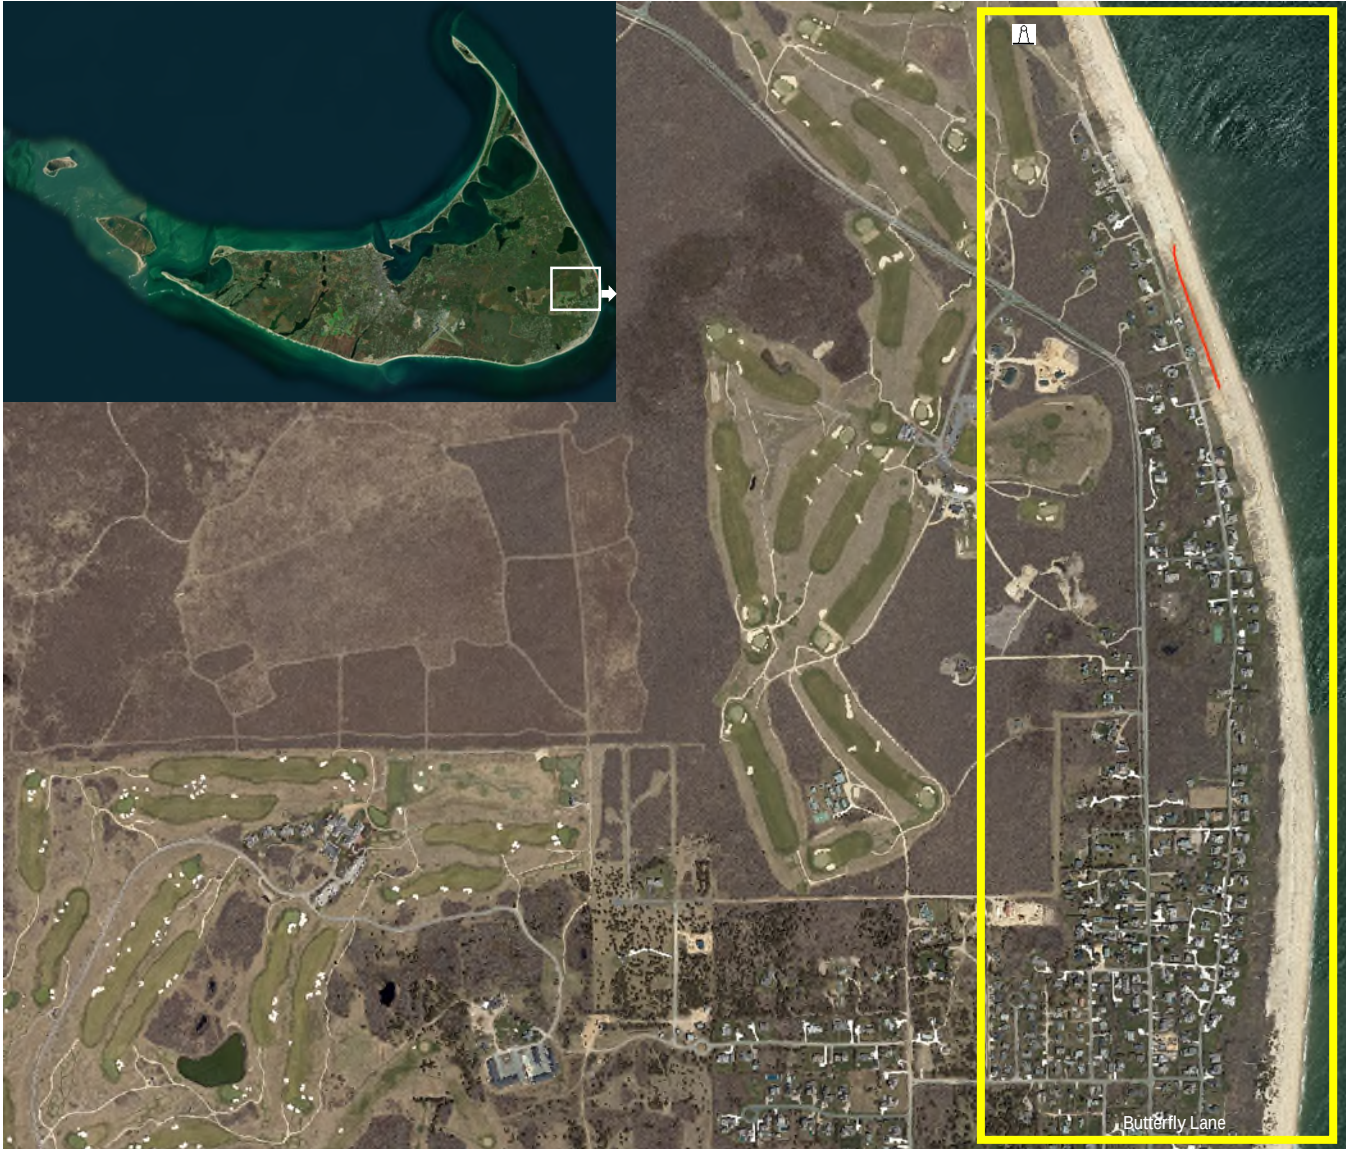
Figure 1: Study area along the coast, with Sankaty Head Lighthouse to the north and Butterfly Lane to the south and present geotubes outlined in red.

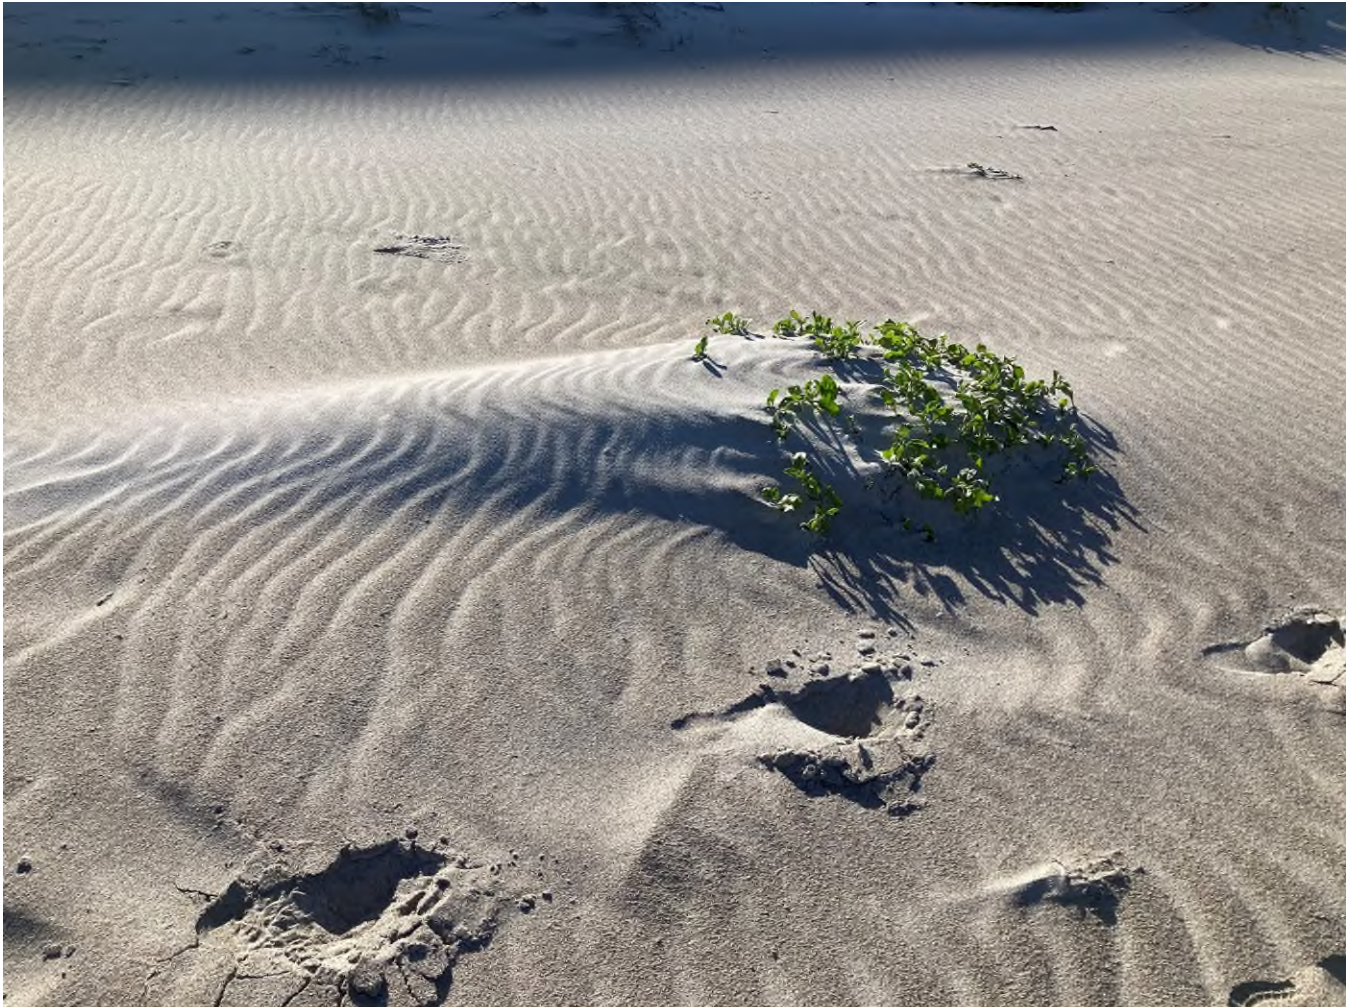
Figure 8. Vegetation trapping wind-blown sand (Indialantic, FL., I. Watts).

(left). The vegetation is trapping wind blown sand creating an elevated feature compared to the surrounding beach surface. Beach nourishment has some limitations to preventing bluff erosion; during larger storm surge events, the storm surge may be higher than the beach elevation, allowing waves to reach and erode the bluff. Dunes can be used to protect a bluff toe, but the protection is provided by allowing the dune to erode sacrificially during storm conditions. As such, the volume of sand above the storm surge elevation needs to be sufficient for a specified design storm condition.

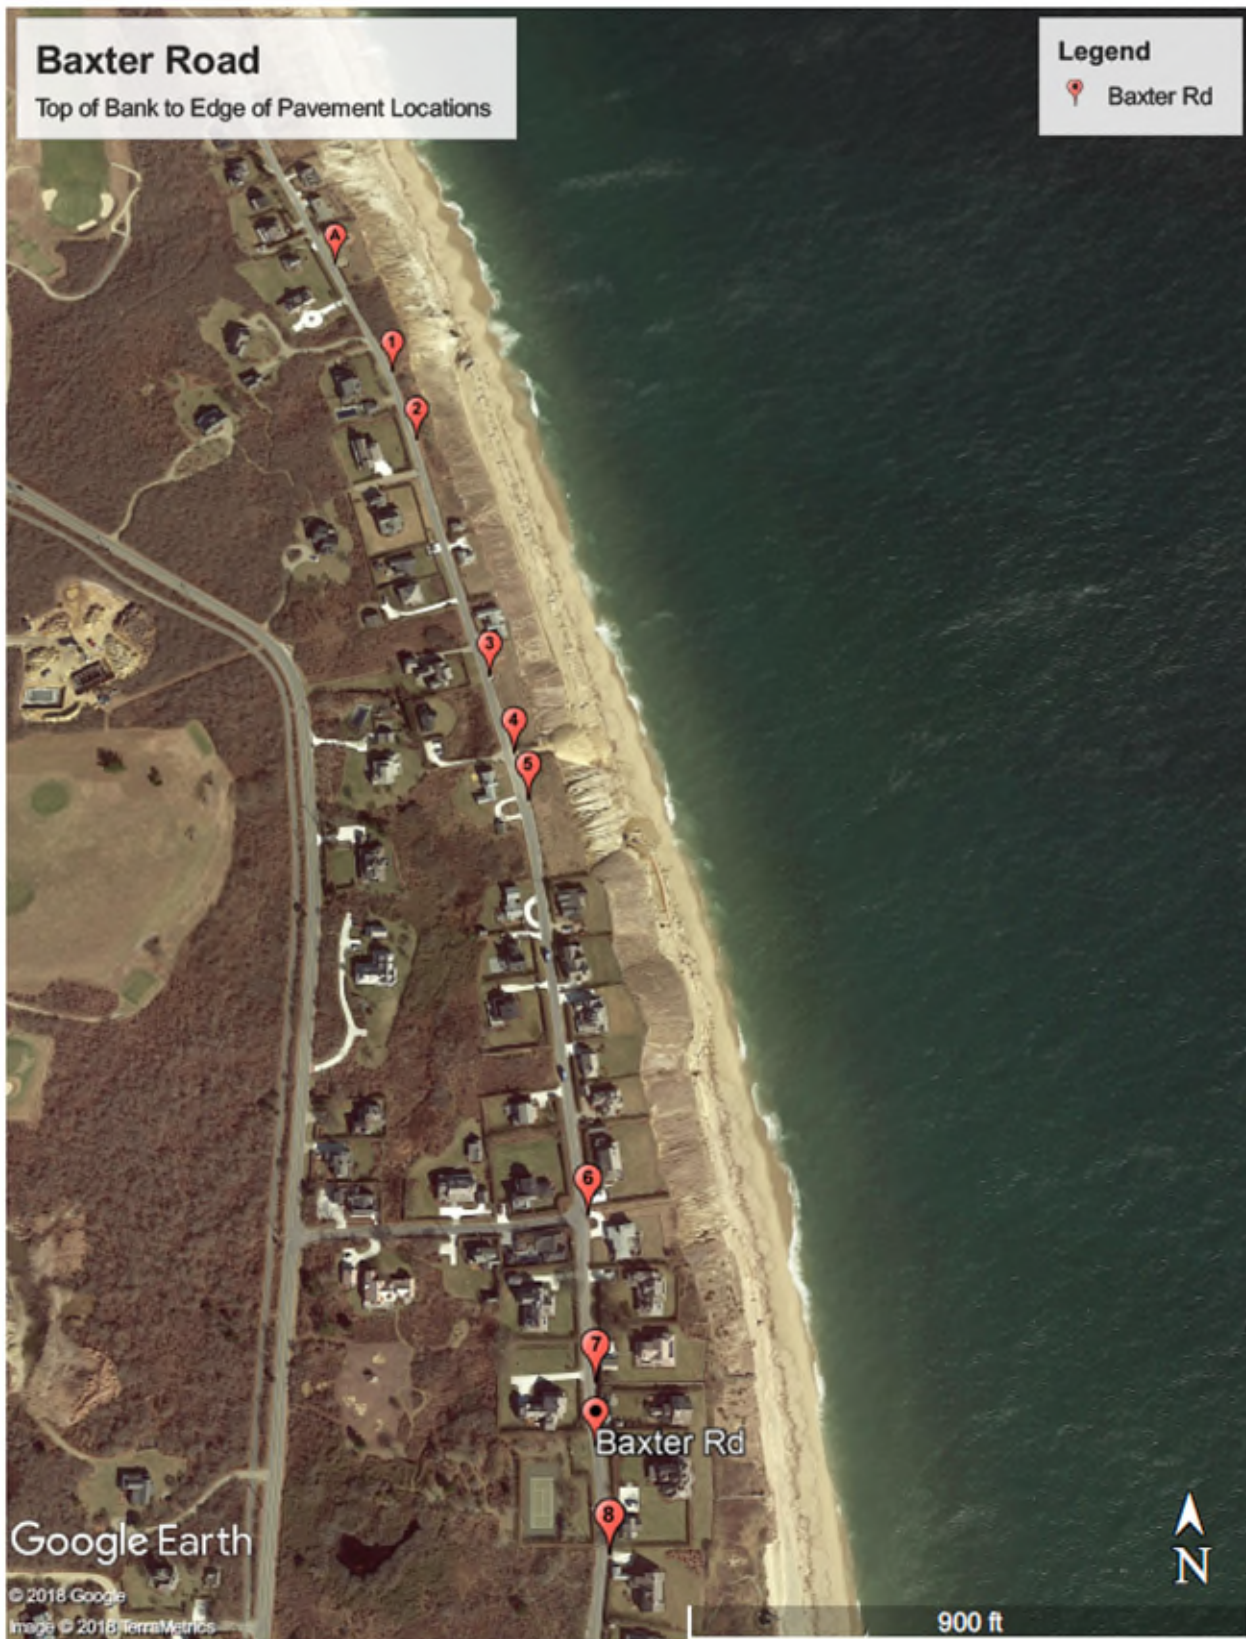
Figure 29. Locations of Baxter Road Bluff Monitoring.

Maintaining both access and water/sewer service to residents will require advanced planning and implementation. As previously studied and recommended by Milone & MacBroom, the integrity of the roadway is likely to become compromised when the top of the bluff is within 25ft of the roadway. It is important that Town has a shovel-ready plan in place to address continued access and utility service well before the 25ft threshold is reached. Table 5 shows the most recent measurements taken by the town during August 2021 and Figure 29 provides an aerial image of the monitoring locations.

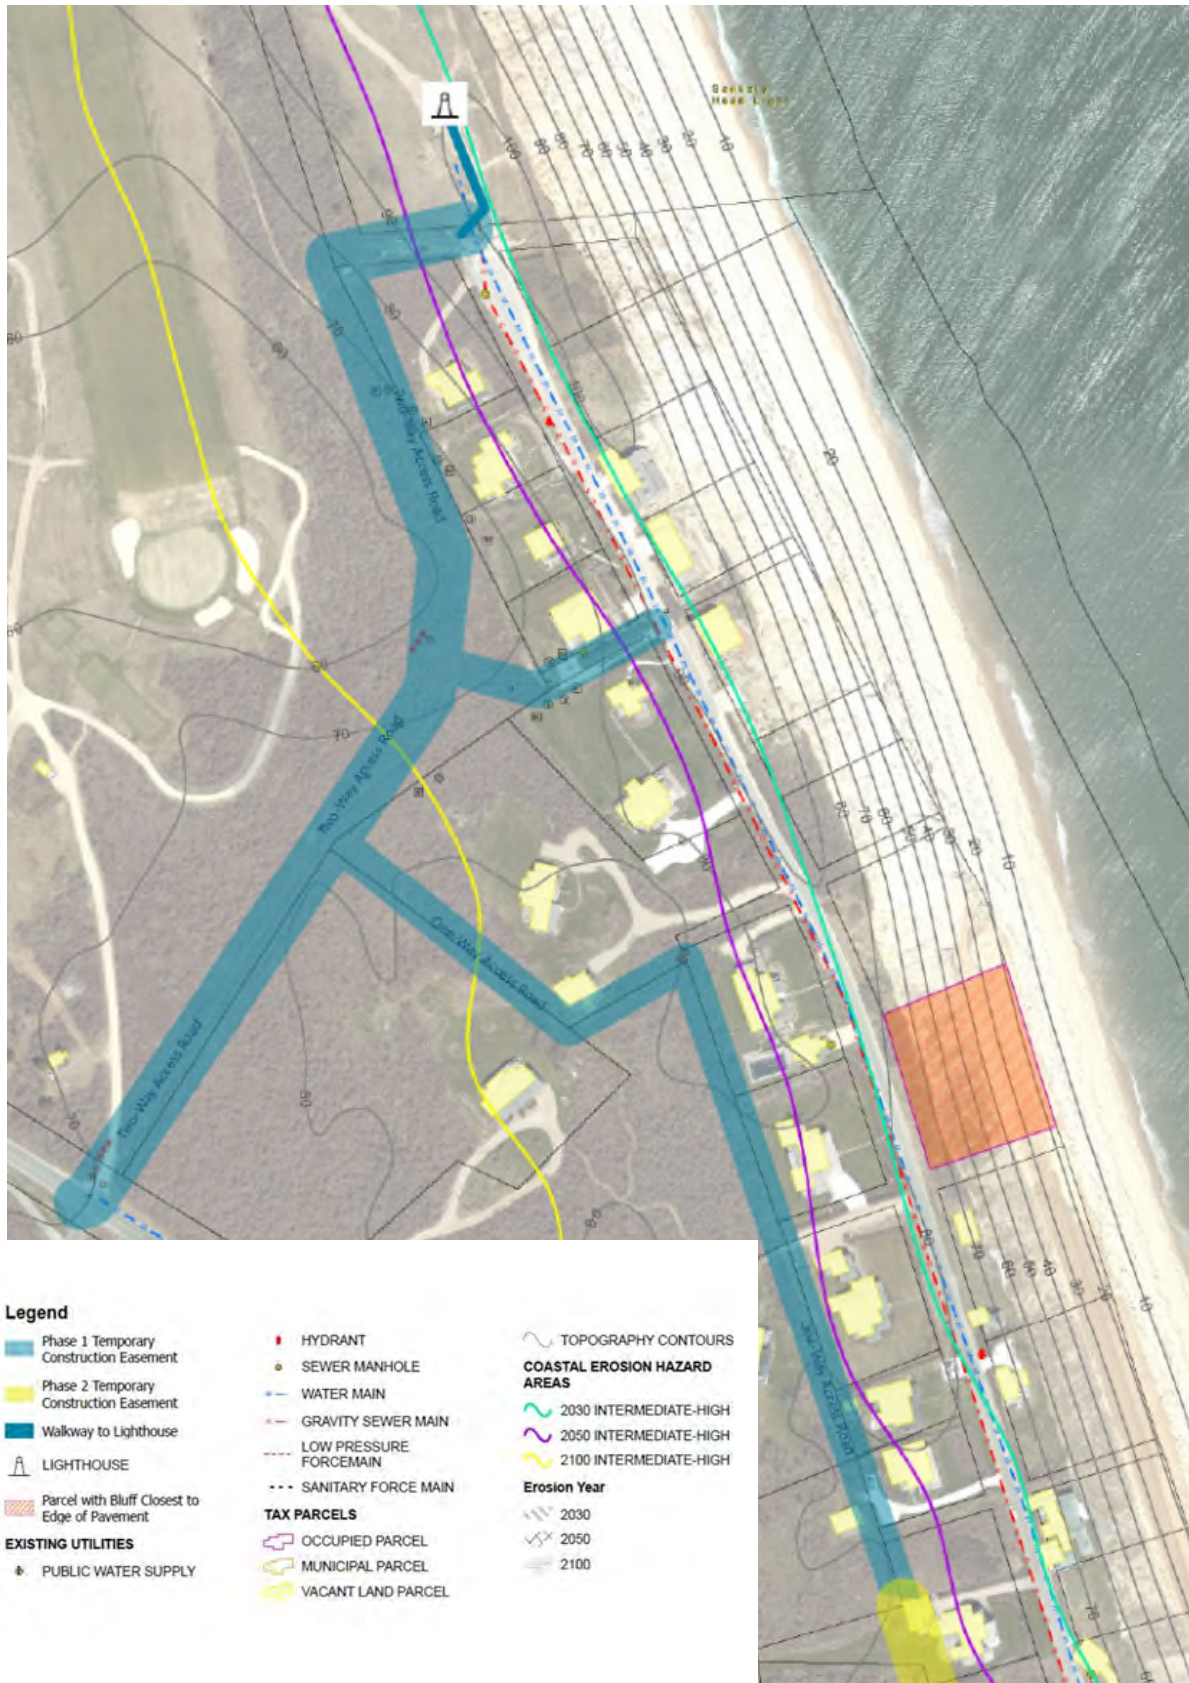
Figure 30 Phase 1 Relocation

The relocation of Baxter Road is considered for affected areas up to the year 2100 according to the FEMA erosion lines. Because of the breadth of the affected area as well as the imminence of the years 2030 and 2050, the relocation is broken up into two phases.

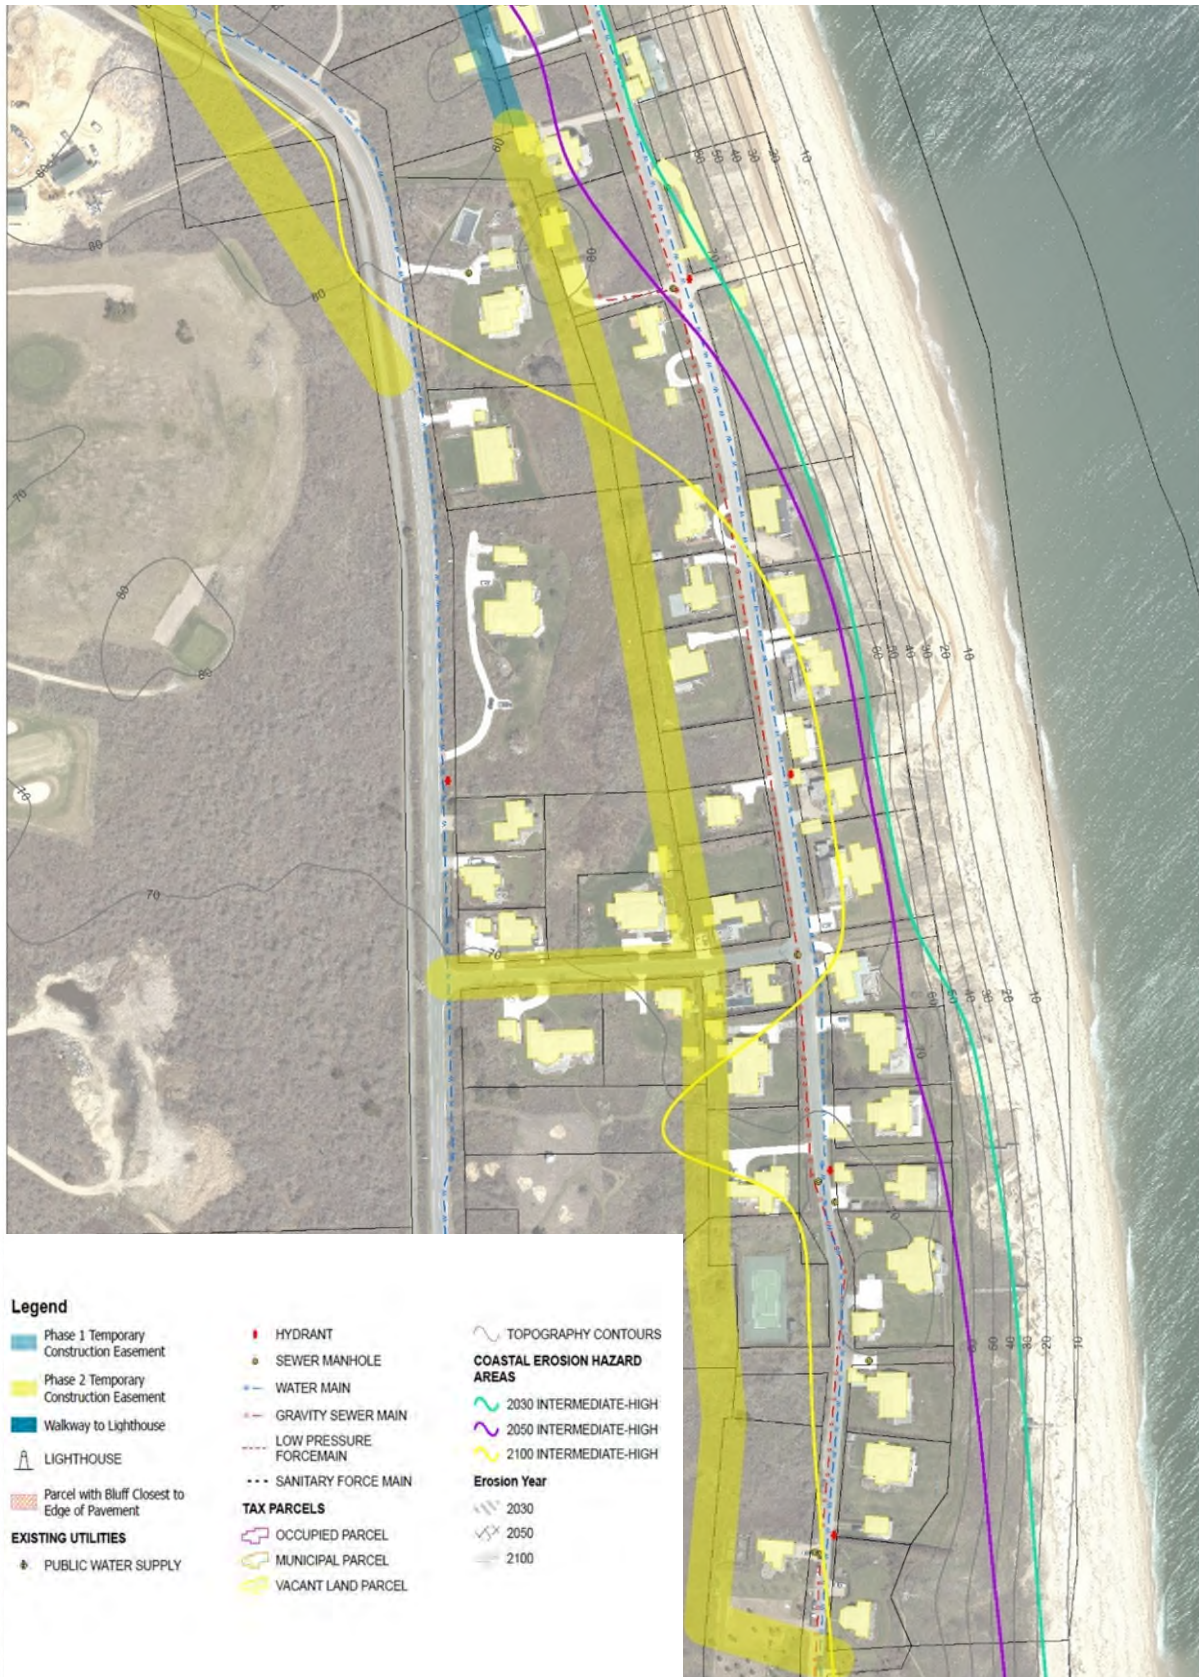
Figure 31 Phase 2 Relocation

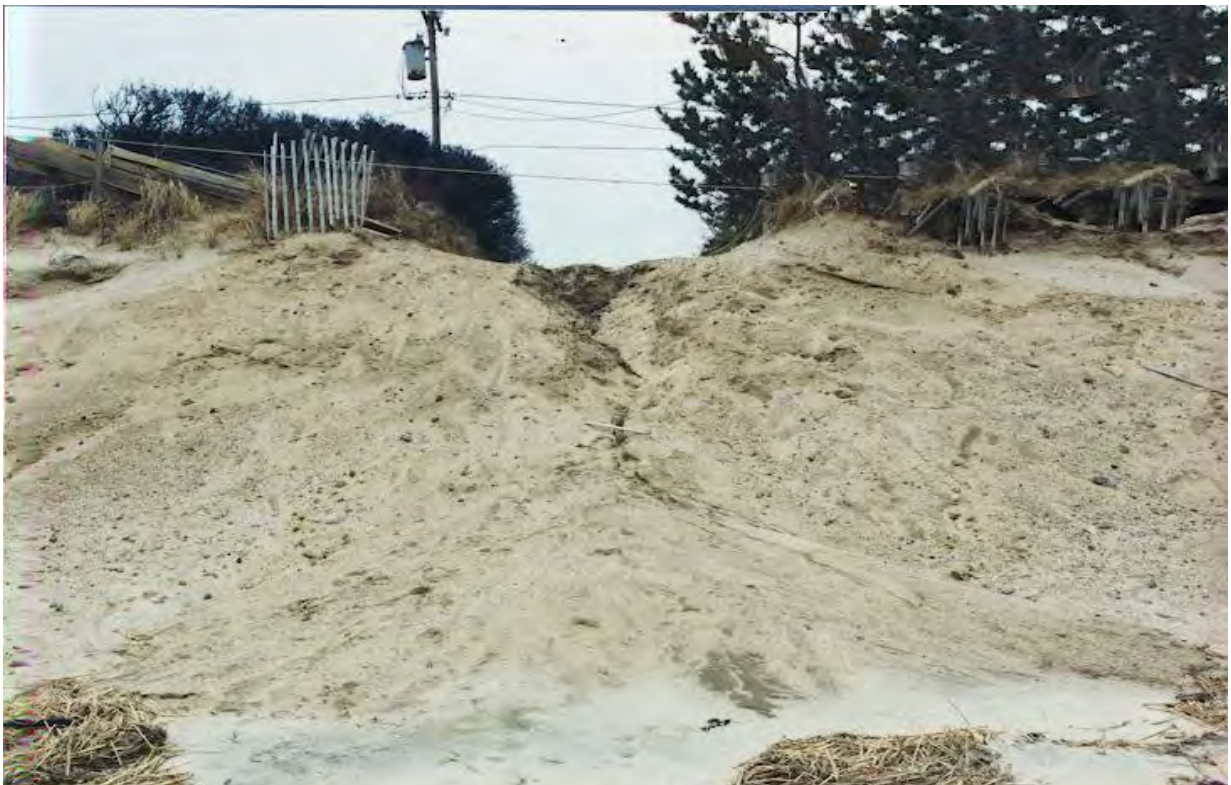
*Runoff has eroded a channel in this bank face, exacerbating the coastal erosion problem. Some of the eroded material has been deposited in a fan-shaped mound at the base of the bank. (Photo: CZM)*

Channels or gullies on the face of a bank or dune are a sign of a runoff problem. As shown in the photograph on the right, sediment carried by runoff is often deposited in a fan-shaped pile at the base of the slope. The channels and fan-shaped deposits are both indicators that runoff is eroding the bank. Similarly, runoff can erode soil from behind concrete seawalls and under rock revetments (i.e., shoreline stabilization structures constructed of sloping rock), causing them to slump or collapse. Indicators that runoff may be contributing to the failure of seawalls and revetments include channels in the bank above the structure or sinkholes behind the structure. If overland sources of runoff are not successfully managed, the effectiveness of other shoreline stabilization techniques can be compromised.

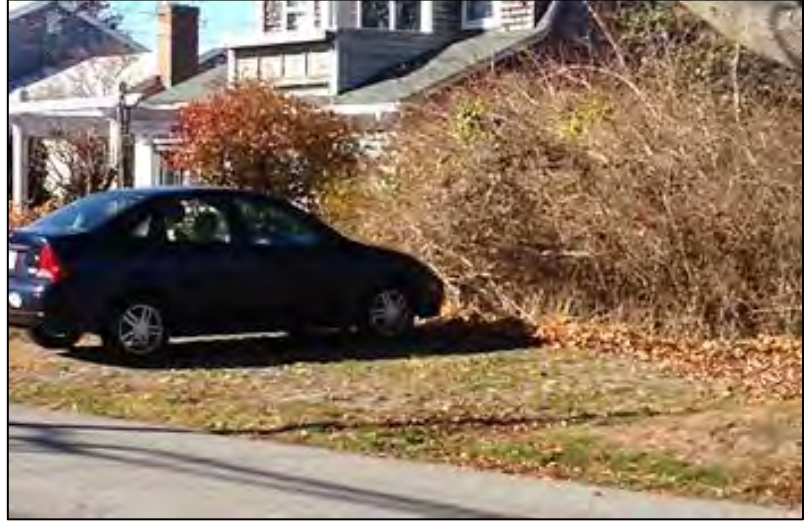
*Several options are available for installing grass driveways, including this grass and paver system. As with all runoff control options, site conditions and potential impacts should be fully evaluated in project design. (Photo: CZM)*

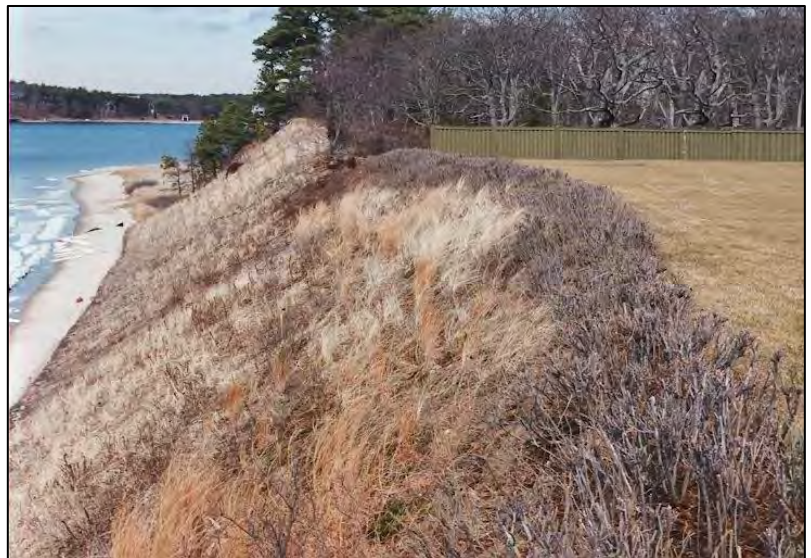
*This lawn was regraded to slope inland, and a buffer of native shrubs was planted along the top of the bank to stabilize the area and direct runoff away from the bank. These measures reduced runoff flowing over the bank so that a bioengineering project with natural fiber blankets, coir rolls, and vegetation could be successfully installed. (Photo: CZM)*

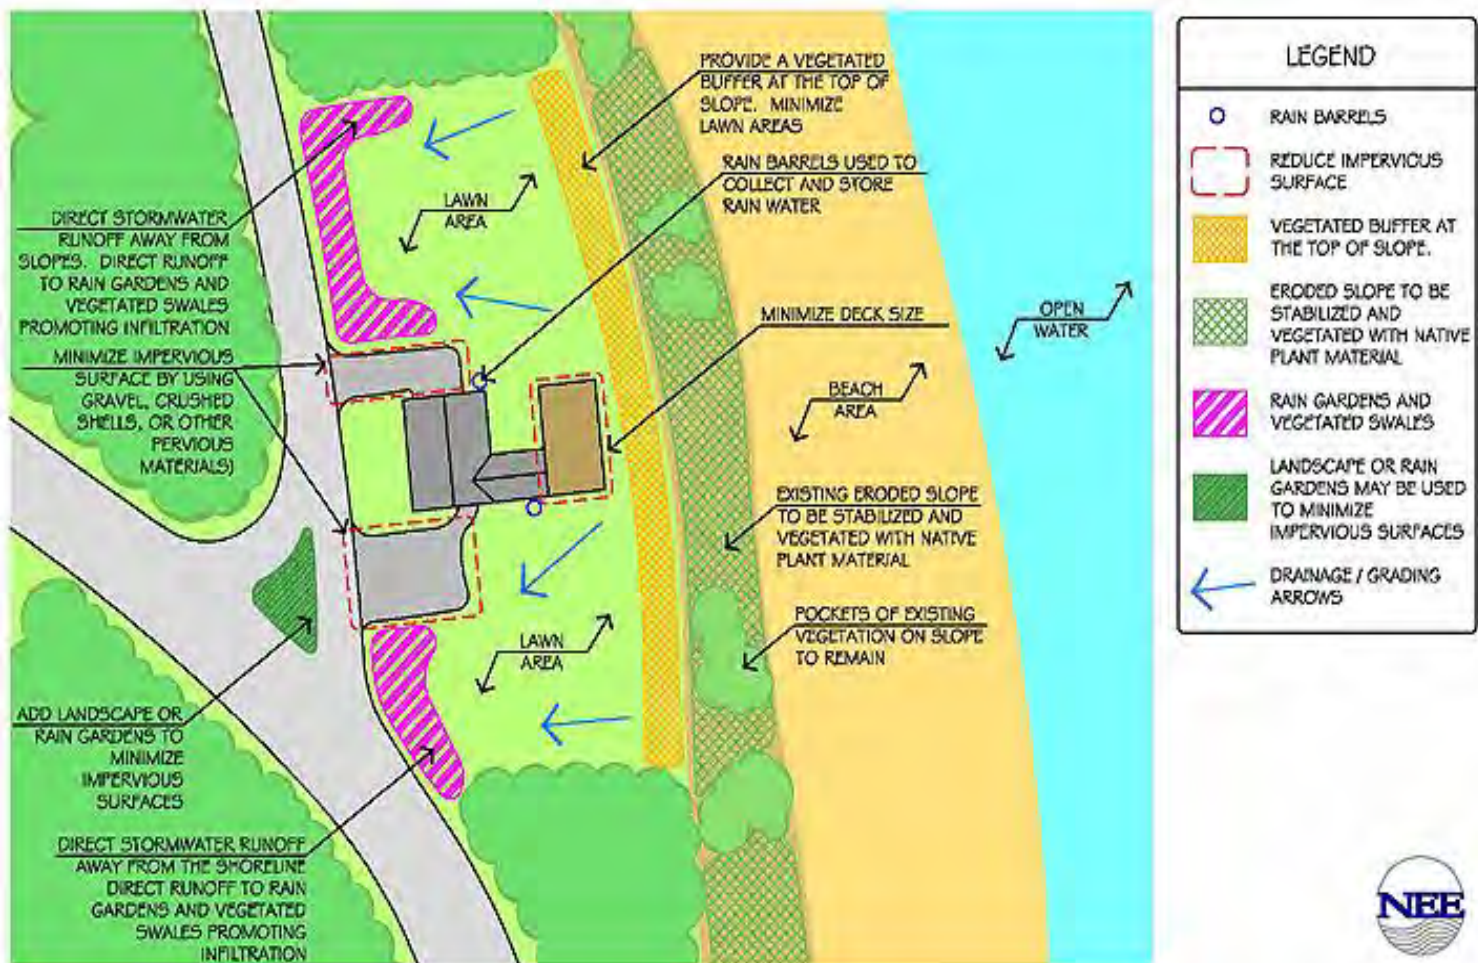
*This figure demonstrates how a typical coastal property could be modified to reduce runoff and where appropriate runoff control techniques could be sited. (Graphic: New England Environmental, Inc.)*

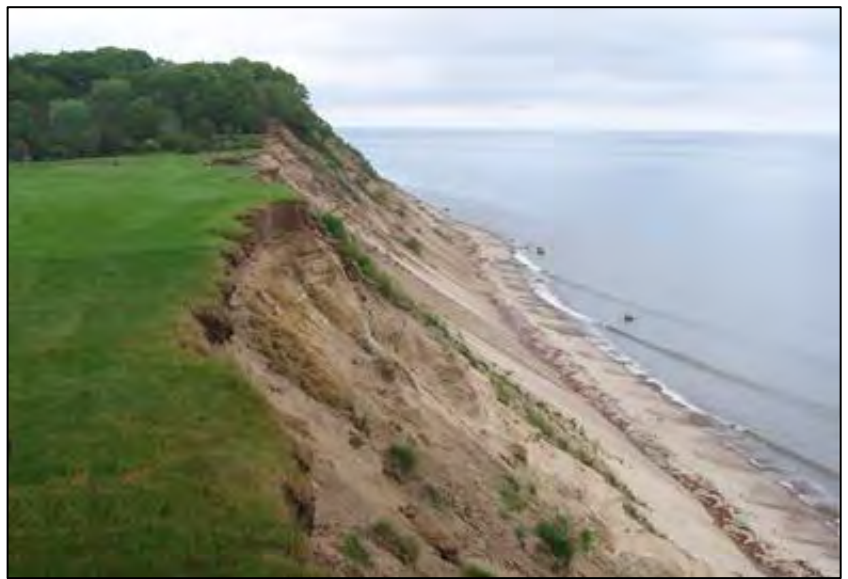
*Extensive irrigated lawns that slope seaward have exacerbated the erosion of this coastal bank. (Photo: CZM)*

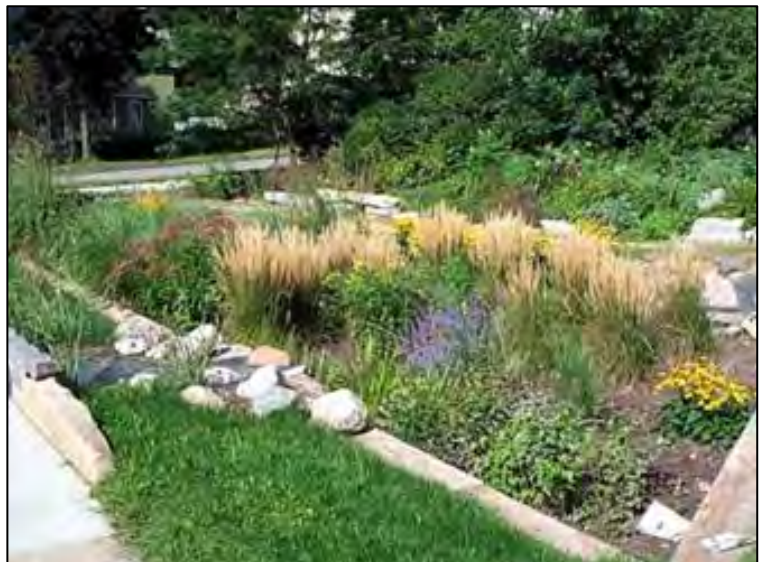
*A large rain garden. (Photo: Massachusetts Bays National Estuary Program)*

Vegetated swales are channel-like depressions in the ground used to slow, filter, and direct water to another location. Rain gardens are wider and flatter depressions that allow for the maximum collection and infiltration of water. Swales and rain gardens both use plants that tolerate both wet and dry conditions to ensure plant survival (swales often use grasses, while rain gardens are planted with a mix of grasses, perennials, shrubs, and trees).

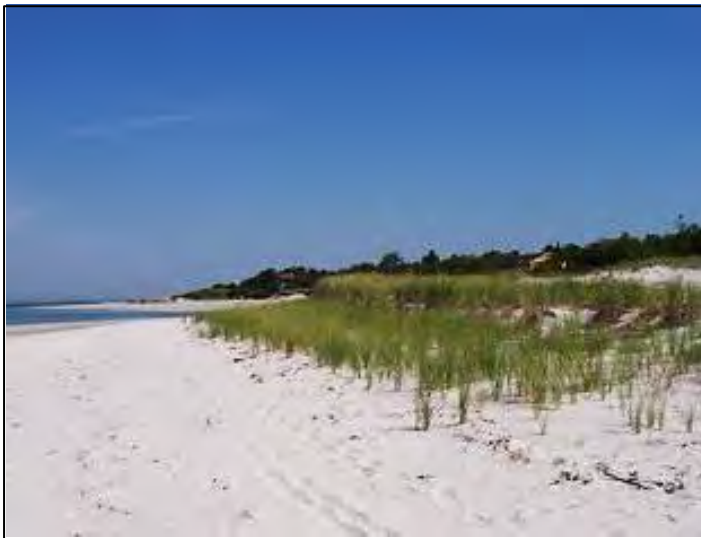
*Beachgrass was planted to stabilize an eroded dune and trap windblown sand to build dune volume. (Photo: CZM)*

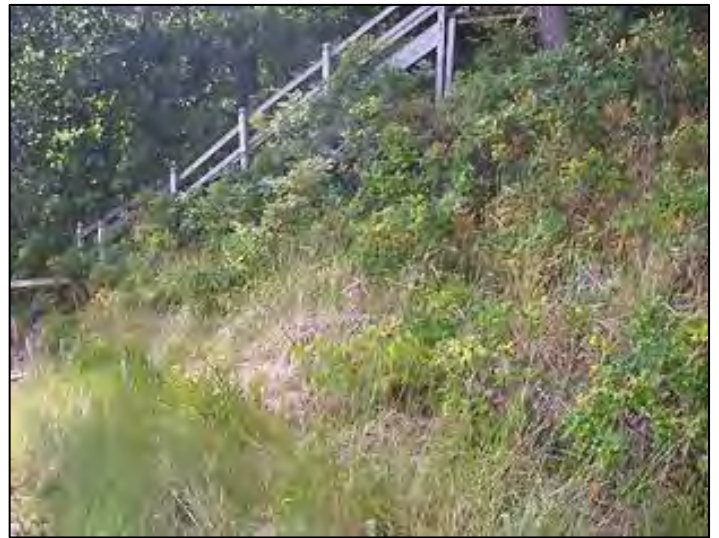
*A variety of salt-tolerant vegetation was planted on the face of this bank to stabilize fill added to address bank erosion. (Photo: CZM)*

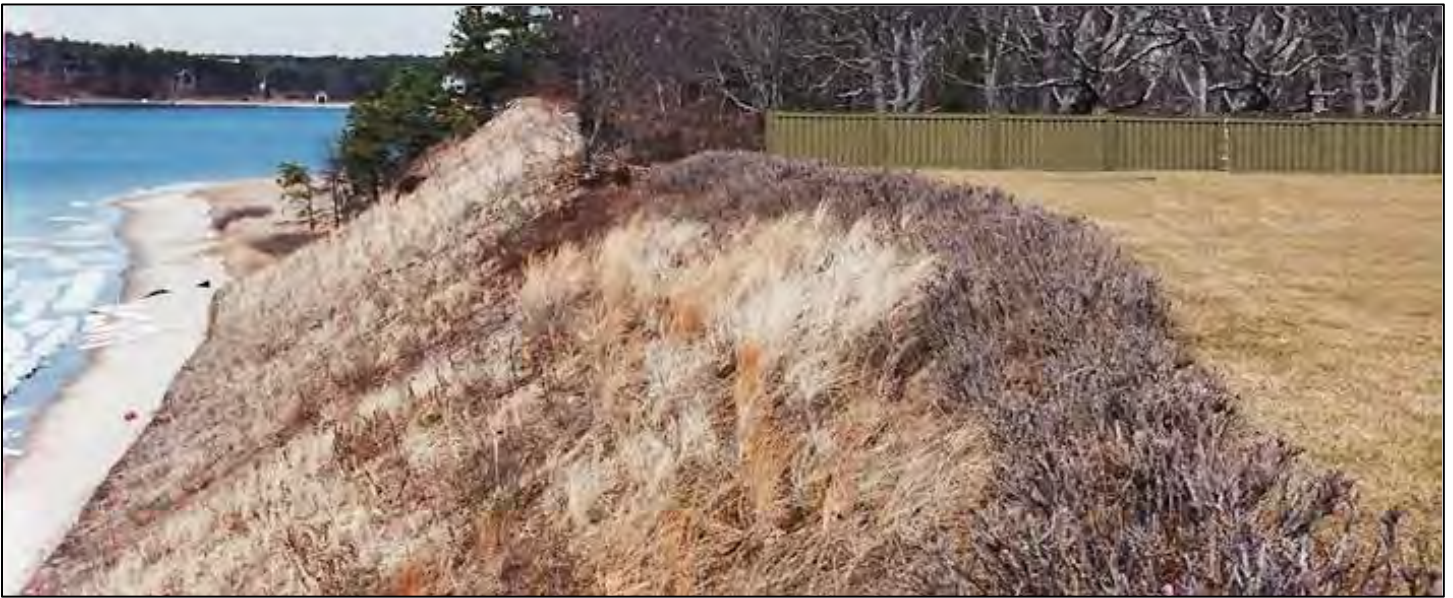
*Shrubs were planted at the top of this bank to slow runoff. On the bank face, natural fiber blankets were installed to hold soils in place until the erosion-control vegetation could get established. (Photo: CZM)*

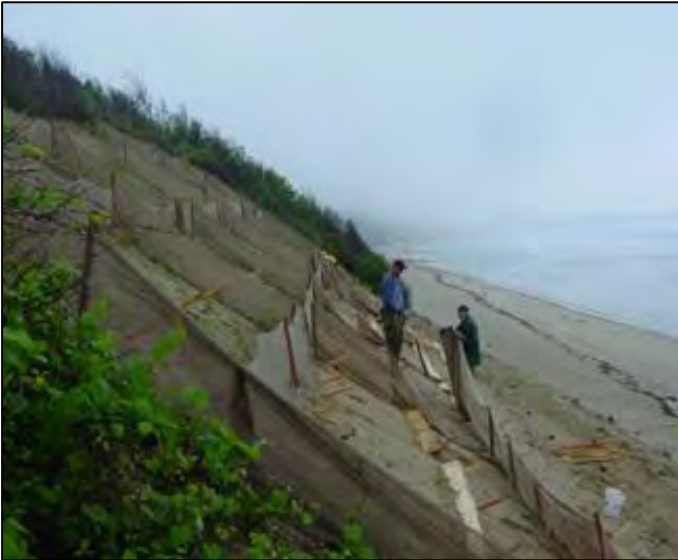
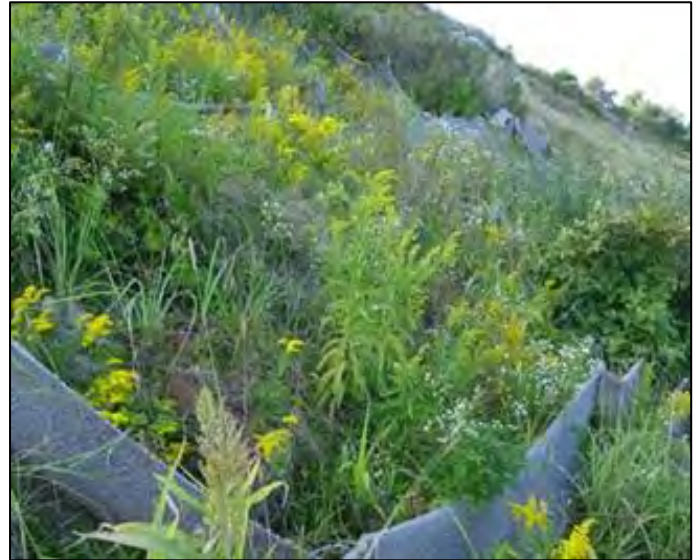
*Lightweight, natural-fiber, erosion-control fabric was installed on this bank to protect the plants from wind until the roots could get established. Boards were placed on top of wooden stakes to provide access during construction, which minimized impacts to the bank from foot traffic. The photo on the right was taken one year after planting. (Photos: New England Environmental, Inc.)*

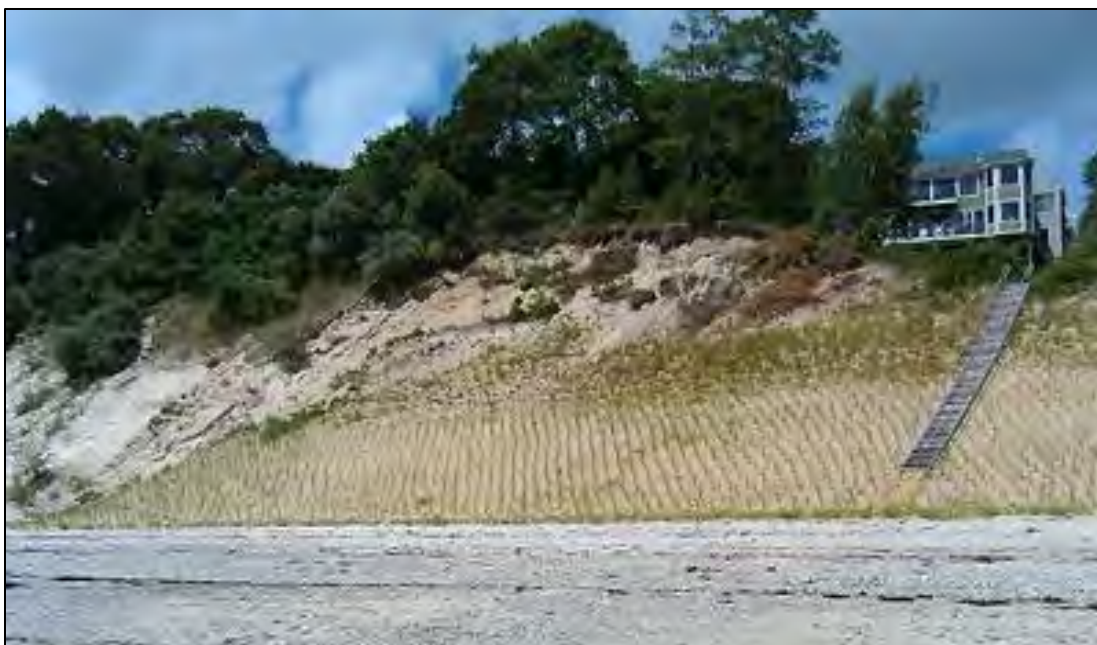
*Sediment was added to this eroding bank to create a shallower and more stable slope before the vegetation was planted. The lower bank was planted with grasses and the upper section with mixed grasses and shrubs. (Photo: CZM)*

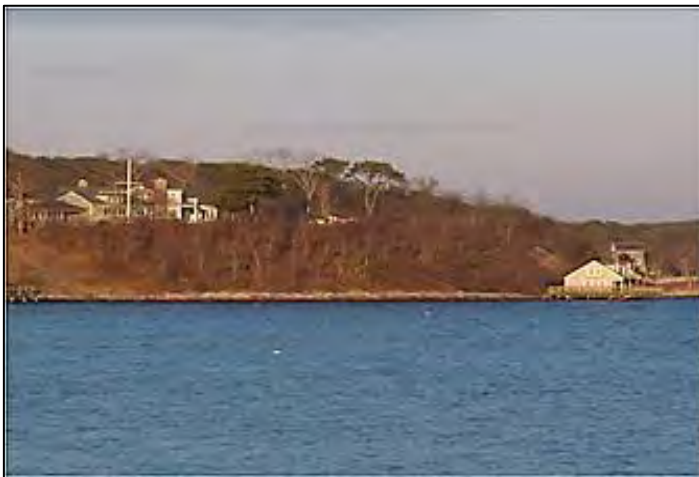
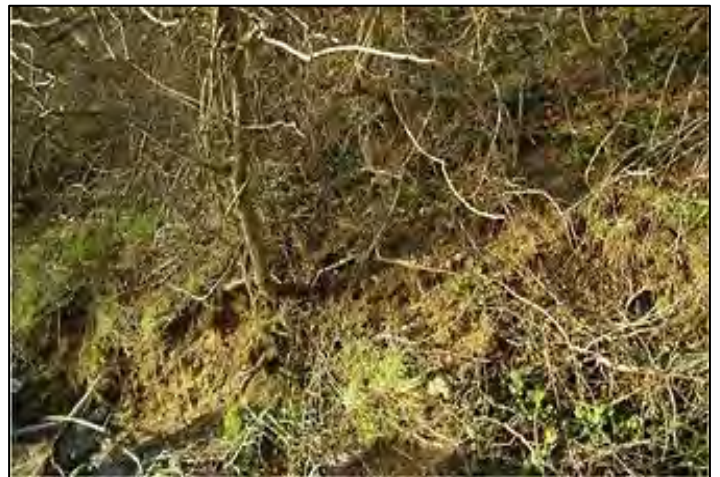
*The photo on the left shows a densely vegetated bank that looks stable, but isn't. The invasive black locust, Asiatic bittersweet, and autumn olive growing on the bank do not have deep, dense roots that help hold soils in place. The photo on the right shows a close up of the exposed soils and erosion at the site. In addition, the roots of these invasive plants secrete toxic compounds and the thick branches shade the area, both of which inhibit the growth of native plants that could stabilize the soil. (Photos: Wilkinson Ecological Design)*

Removing invasive plants to replace them with native species, however, can temporarily destabilize the bank. For sites where bank regrading is not needed, invasive plants should be cut off at ground level, keeping the roots in place to minimize site disturbance. Many invasive plants can be effectively eliminated by applying limited amounts of herbicide to the cut stems, which kills the remaining root material. Herbicides can only be used in areas where they are allowed by local regulations. A direct and targeted application of herbicides, as opposed to spraying, helps
